Appendix 20b: Thorne report

NOTIFICATION OF AN EVENT

FINAL REPORT

Advice Not to Drink Water at Thorne, nr. Doncaster, South Yorkshire **29th July - 4th August, 2016**

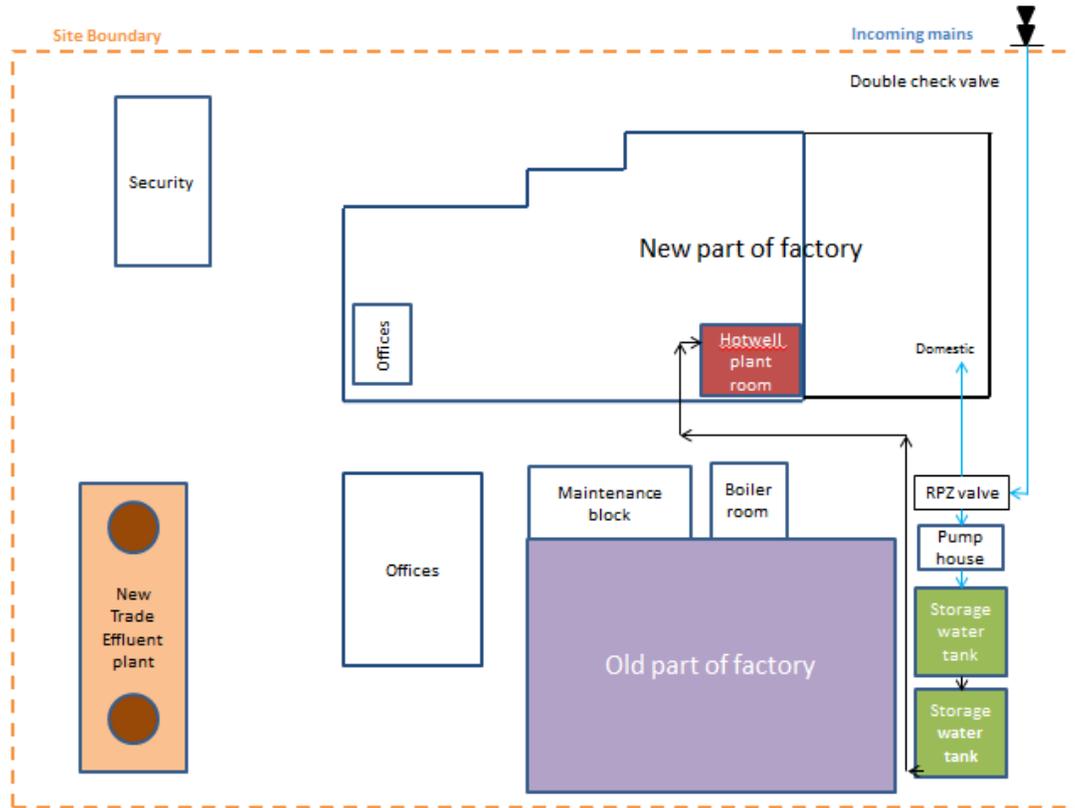
Figure 2 PPF layout

At around 11:00am a water regsWater Regulations inspection was undertaken at the PPF. The factory was found to be broadly split into two parts, the original factory site and a new build section. A sketch of the PPF layout is shown below in Figure 1.

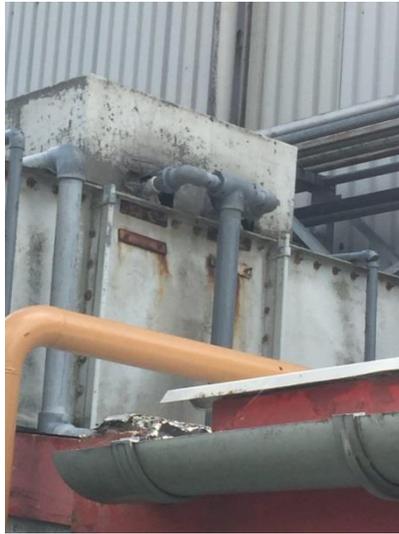
The WRI was told that all of the water used in production was fed directly from two large storage tanks. The tanks were inspected and found to have compliant AB air gaps as seen in Figure 2.

Figure 3: PPF storage tanks with incoming mains feed.

This implied that backflow into the mains from the PPF storage tanks should not be possible. The WRI requested schematic drawings in order to confirm the pipework layout but was told that no drawings had yet been created by the contractor.

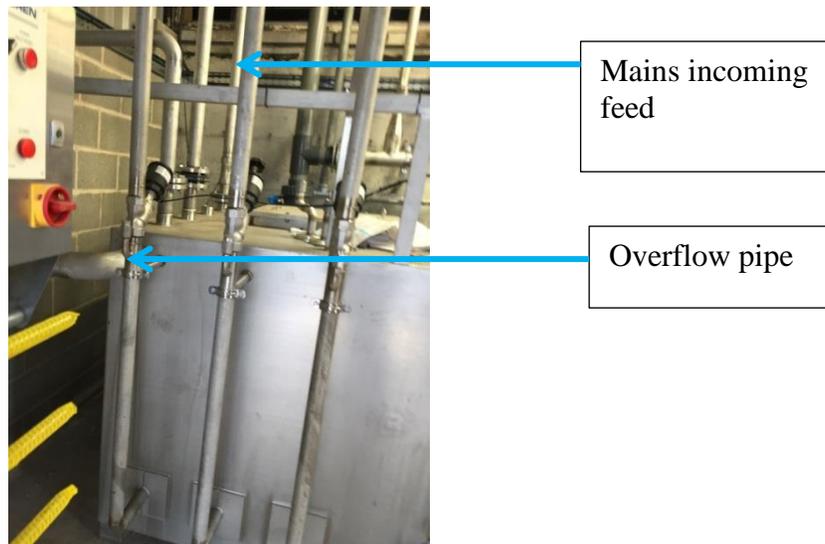
Figure 4: feed in to hotwell with possible mains incoming feed below overflow pipe

The WRI inferred that the incoming mains pipe could instead be a “dip pipe” that reached below the overflow pipe to the bottom of the hotwell tank. This would compromise the AF airgap and could have led to backflow from the hotwell.

The WRI attributed the likely cause of the warm, discoloured water to the hotwell and risk assessed the fluid risk to be under Category 2 of the Water Supply (Water Fittings) Regulations 1999. Since a fluid Category 2 risk is not defined as health impacting an on the spot report was issued for installation of a single check valve. As a precaution, boundary protection was also requested by way of the installation of a double check valve on the incoming main to the PPF.

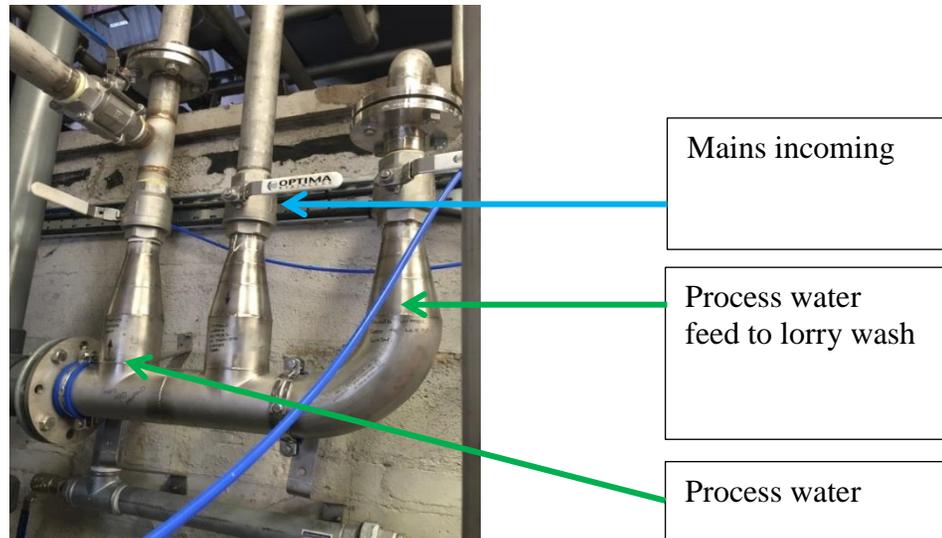
The WRI identified four separate cross connections between mains potable water and various other water sources within the PPF that were under high pressure. These are shown in Figures 4, 5, 6, and 7 below. The WRI immediately spoke with the PPF site engineer and arranged for the water supply to the PPF to be isolated from the mains network.

Figure 5: cross connection from mains to process water feeding hotwell (defect number 5 on water regs report in the Appendix 24)

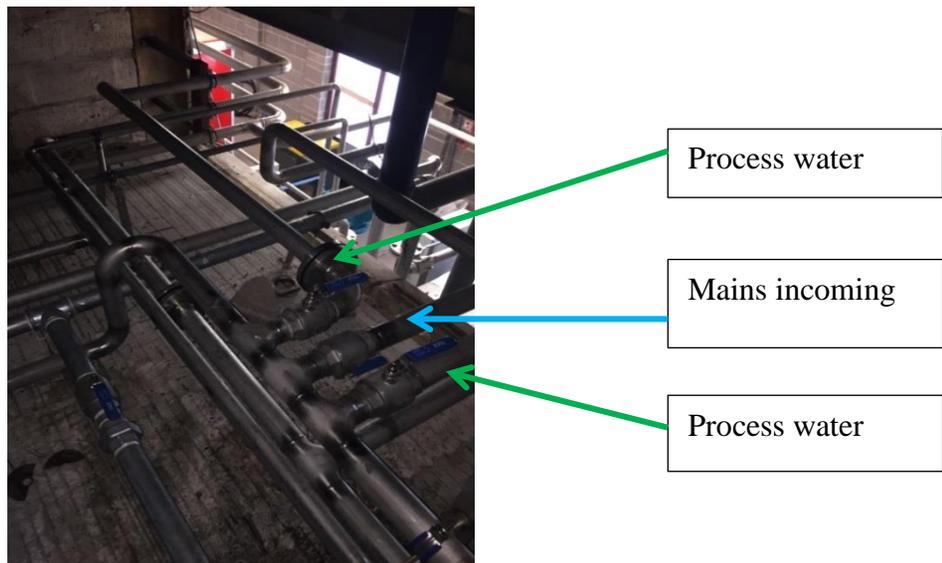
Figure 6: cross connection from mains to process water in roof space before hotwell (defect number 6 in water regs report in the Appendix 24²³)

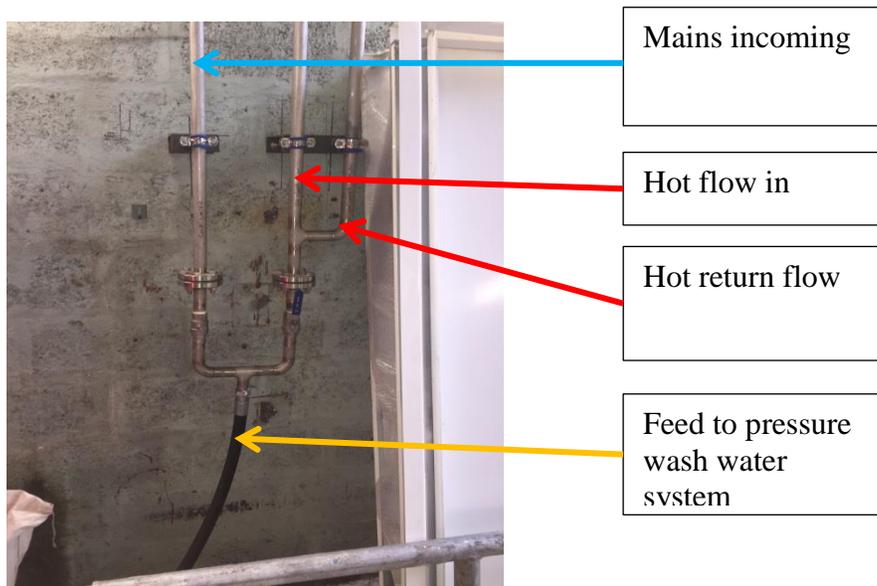
Figure 7: cross connection in boiler room feeding pressure wash water system (defect number 9 in water regs report in the Appendix 24)

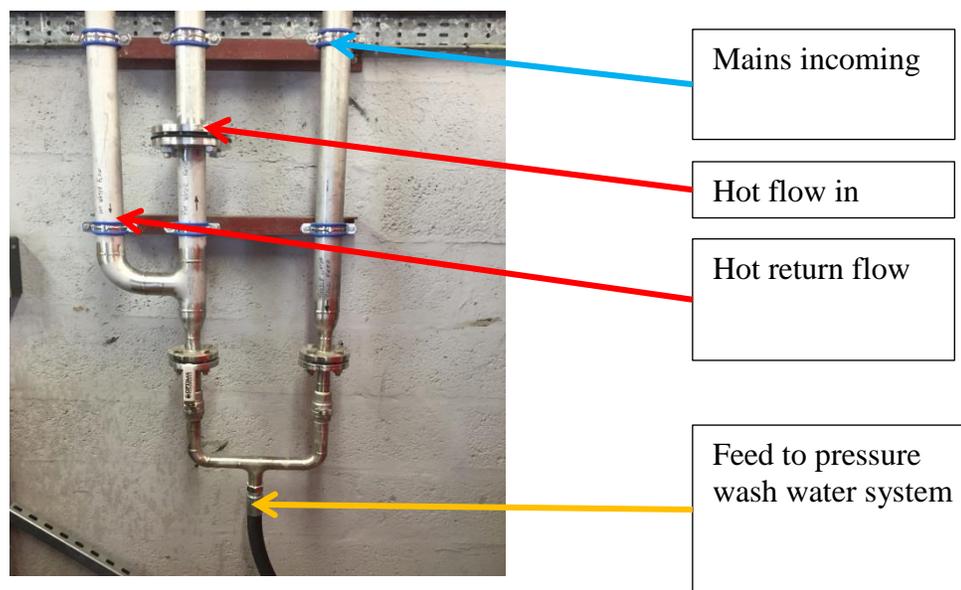
Figure 8: cross connection in hotwell plant room feeding pressure wash water system (defect number 7 in water regs report in the Appendix 24)

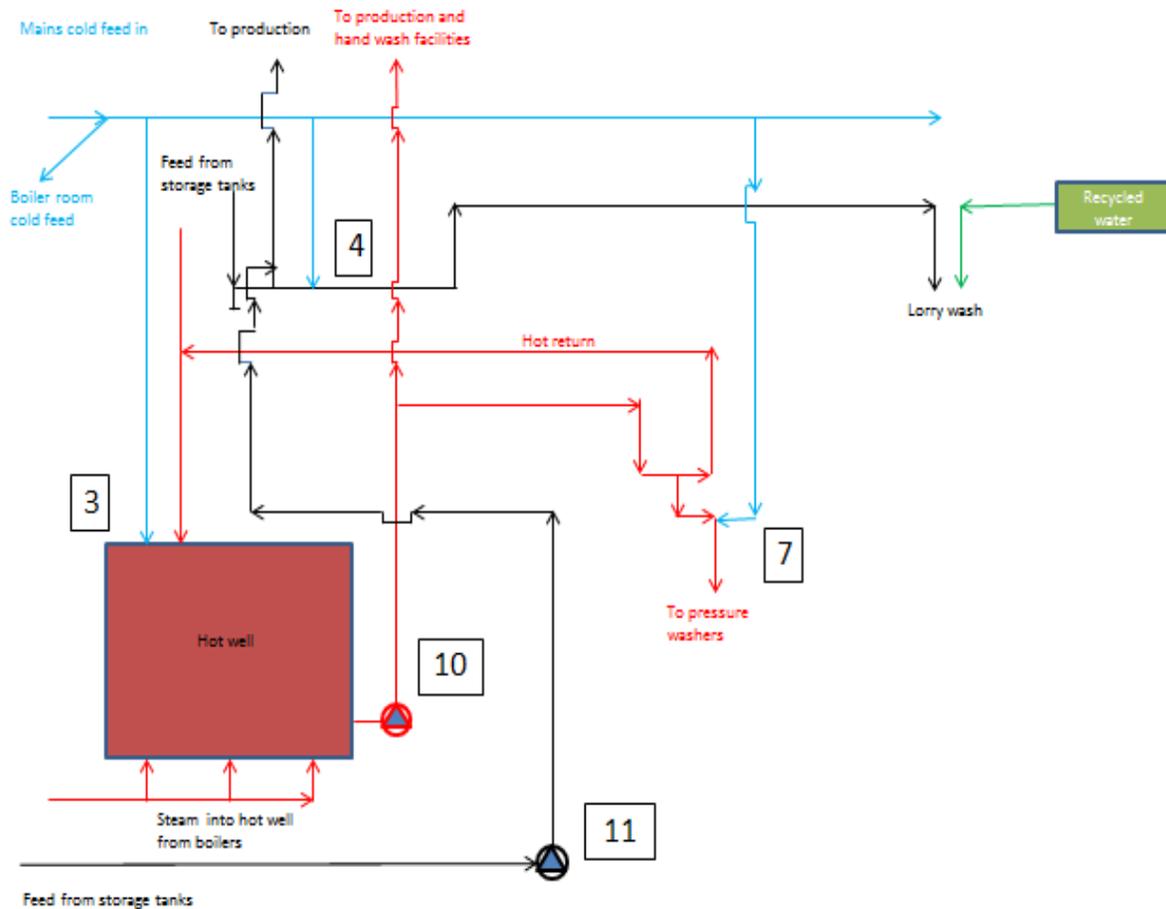
Figure 9: diagram showing cross connections in hotwell plant room with corresponding Figure numbers referenced in this report.

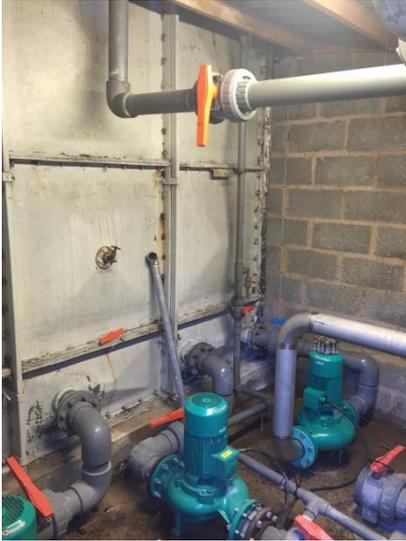
Figure 10: pump house

The WRI inspection of the PPF continued on Saturday 30th and further contraventions were identified. It was confirmed that the PPF had the capability to raise pressure by 16-bar as seen in Figure 10, 11 and 12 below.

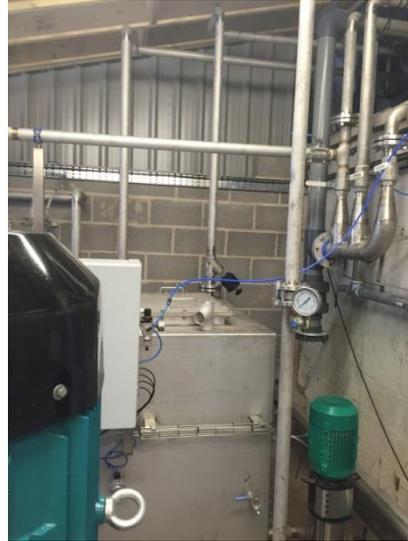
Figure 11: pumped outlet hotwell

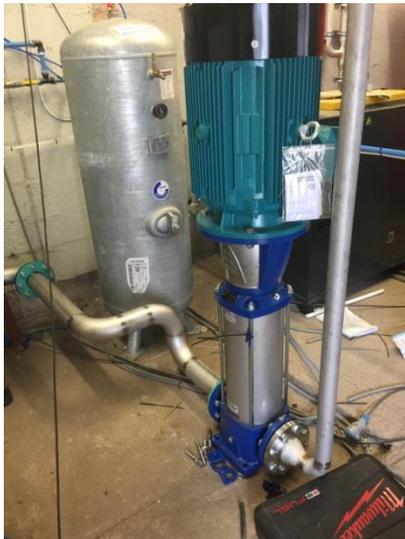
Figure 12: pumped outlet storage tank

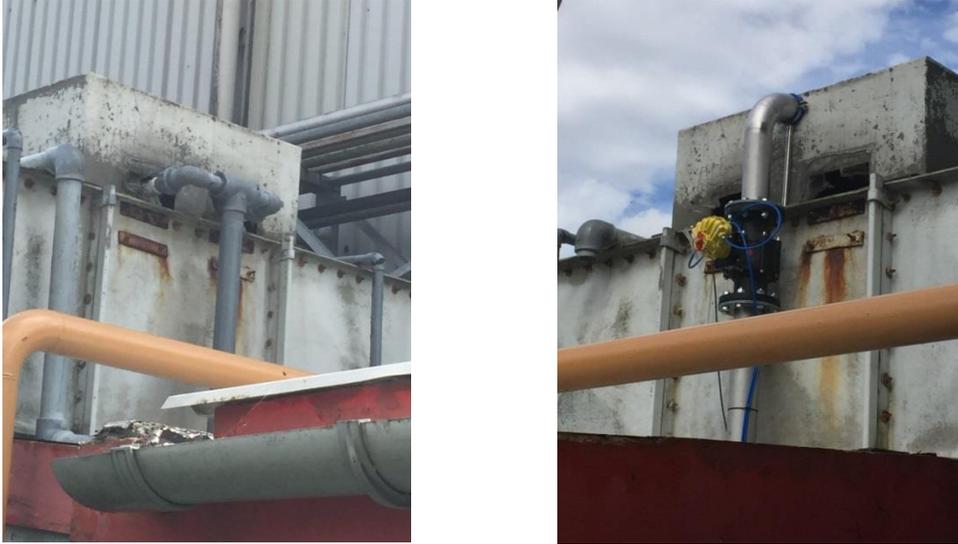
Figure 13: storage tank incoming mains supply before and after modification

The PPF had already commenced work on contraventions that had been identified and were advised on site by the WRI. The pipework feeding the storage cistern was modified so that there was a single incoming mains pipe and an AA airgap was created as seen in the before and after images in Figure 13 below.

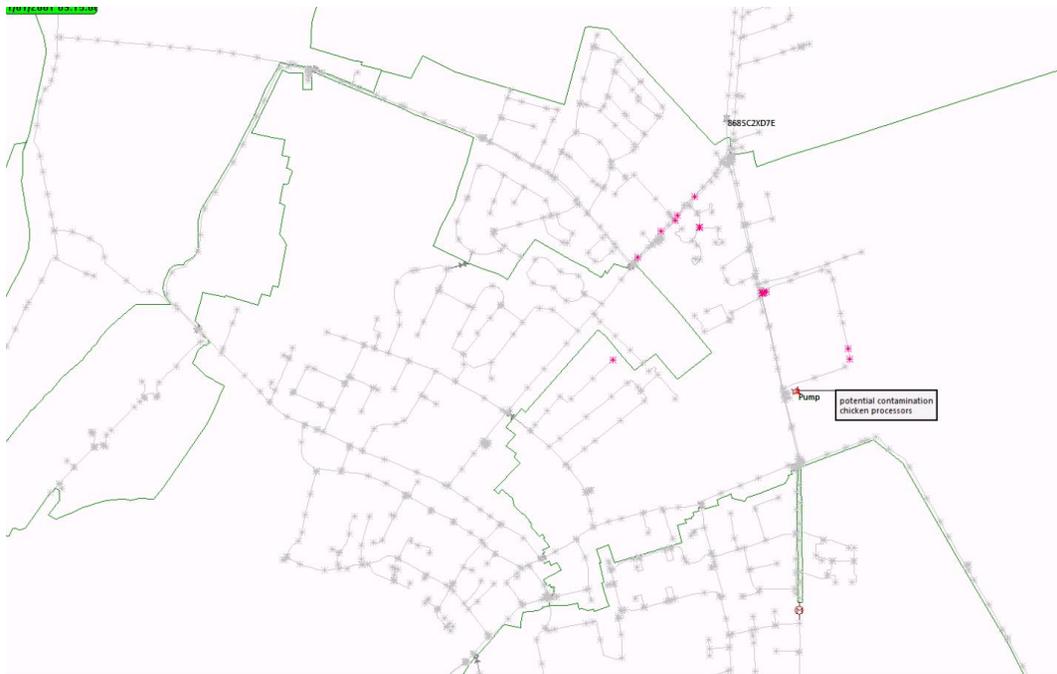
A network model was run by the Company to evaluate the likely pressure required to change the night flow of the system by 3 to 4 l/s and to trace how contaminated water might be distributed through the network. It was demonstrated that for a flow of 3 to 4 l/s to be generated into the network on Coulman Road at the location of the Poultry Processing Factory, a pressure of approximately 30 meters head during the night time period would be required. However, at this pressure there would be no inflow to the DMA from this source between approximately 06:00 hrs and 02:00hrs due to the increased pressure from Thorne WPS which would be running to meet demand.

Figure 18 snapshot from hydraulic model of scenario
