Figure A4.1  
Black Brook 1  
Physical Environment Information

Figure A4.2  
River Colne 1  
Physical Environment Information

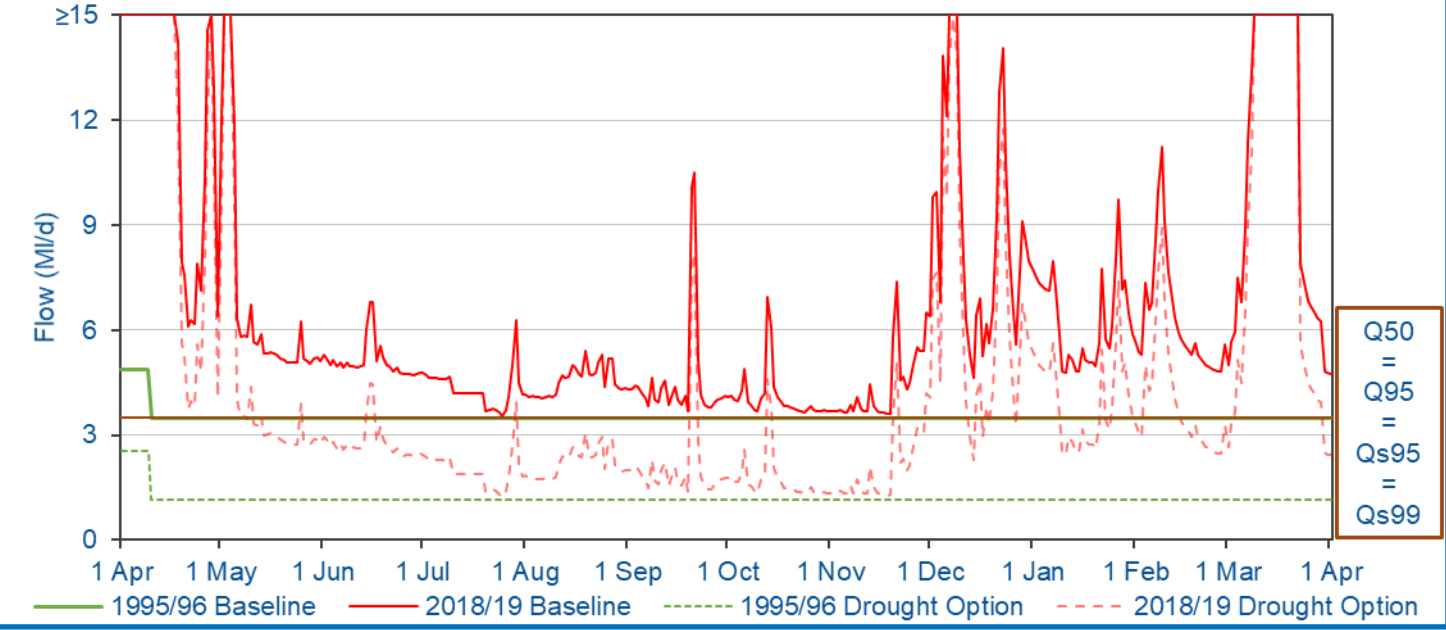
River Flow Regime

Reference Conditions (ML/d)	Drought Plan Conditions (ML/d)	% Reduction	Impact
Q <sub>s</sub> 95	3.49	1.15	67	Summer Major
Q <sub>s</sub> 99	3.49	1.15	67	
Q95	3.49	1.15	67	Winter Major
Q50	3.49	1.15	67

Significant Flow Additions/Reductions	Flow Rate (ML/d)	Abstraction / Discharge
BLACK BROOK 2/27/12/127	0.682	Abstraction
BLACK BURN BROOK-STAINLAND 2/27/12/226	3.1823	Abstraction

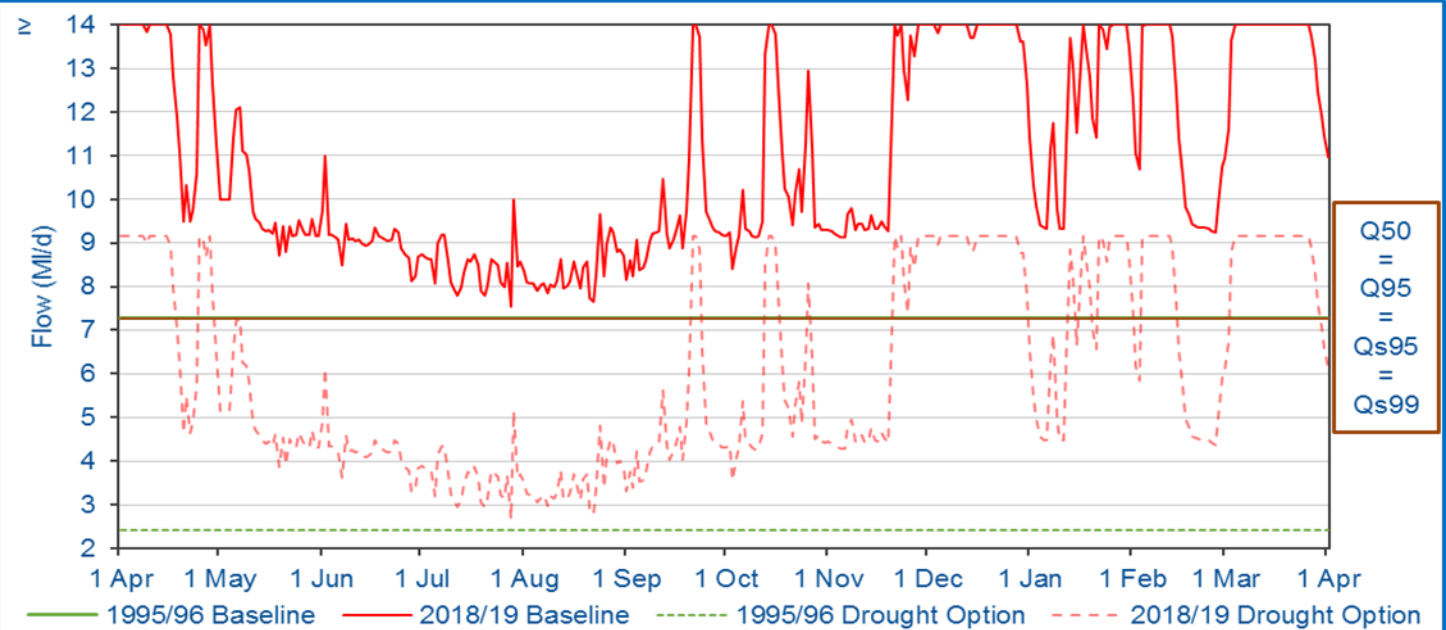
River Flow Regime

Reference Conditions (Ml/d)	Drought Plan Conditions (Ml/d)	% Reduction	Impact	Significant Flow Additions/Reductions	Flow Rate (Ml/d)	Abstraction / Discharge
Q <sub>s</sub> 95	7.27	2.40	67	Summer Major	River Colne 2/27/11/053	0.6	Abstraction
Q <sub>s</sub> 99	7.27	2.40	67				
Q95	7.27	2.40	67	Winter Major			
Q50	7.27	2.40	67

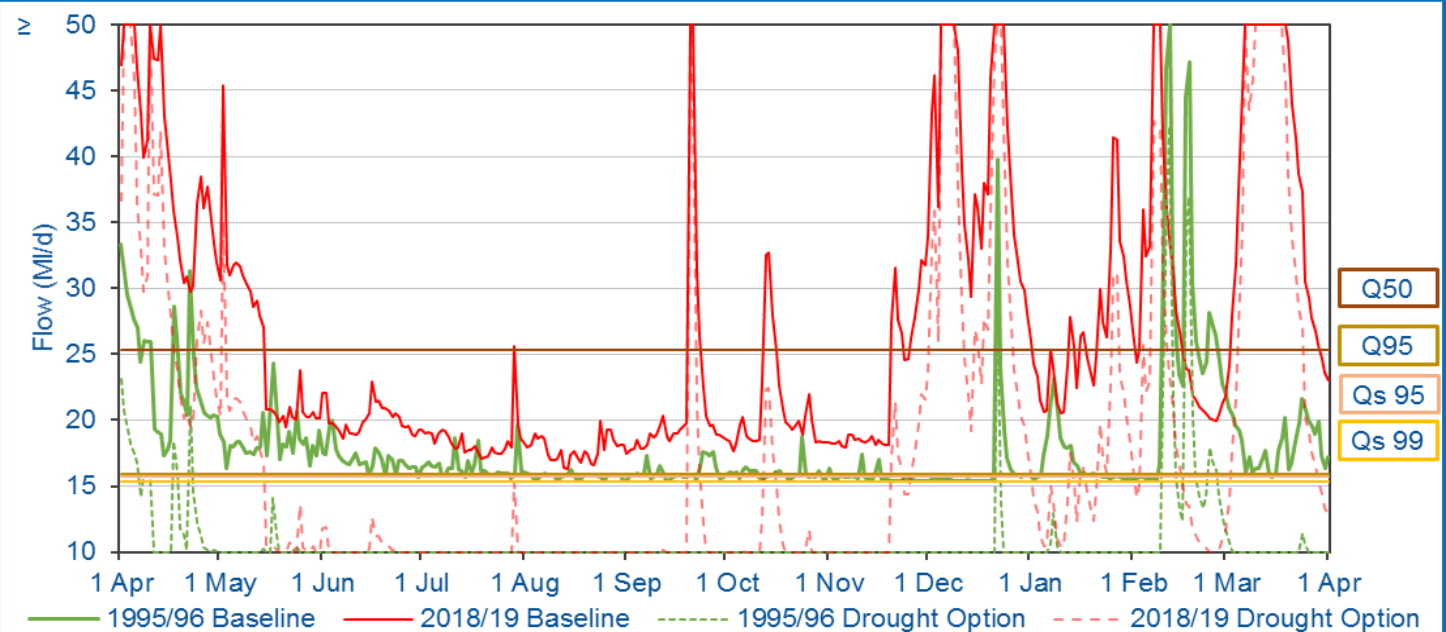
River Flow Regime

Reference Conditions (Ml/d)	Drought Plan Conditions (Ml/d)	% Reduction	Impact	Significant Flow Additions/Reductions	Flow Rate (Ml/d)	Abstraction / Discharge
-					RIVER COLNE- MARSDEN 2/27/11/108	23.87	Abstraction
Q <sub>s</sub> 95	15.80	5.52	65	Summer Major			
Q <sub>s</sub> 99	15.40	5.12	67	Summer Major			
Q95	16.07	5.79	64	Winter Major			
Q50	25.91	15.63	40	Winter Major

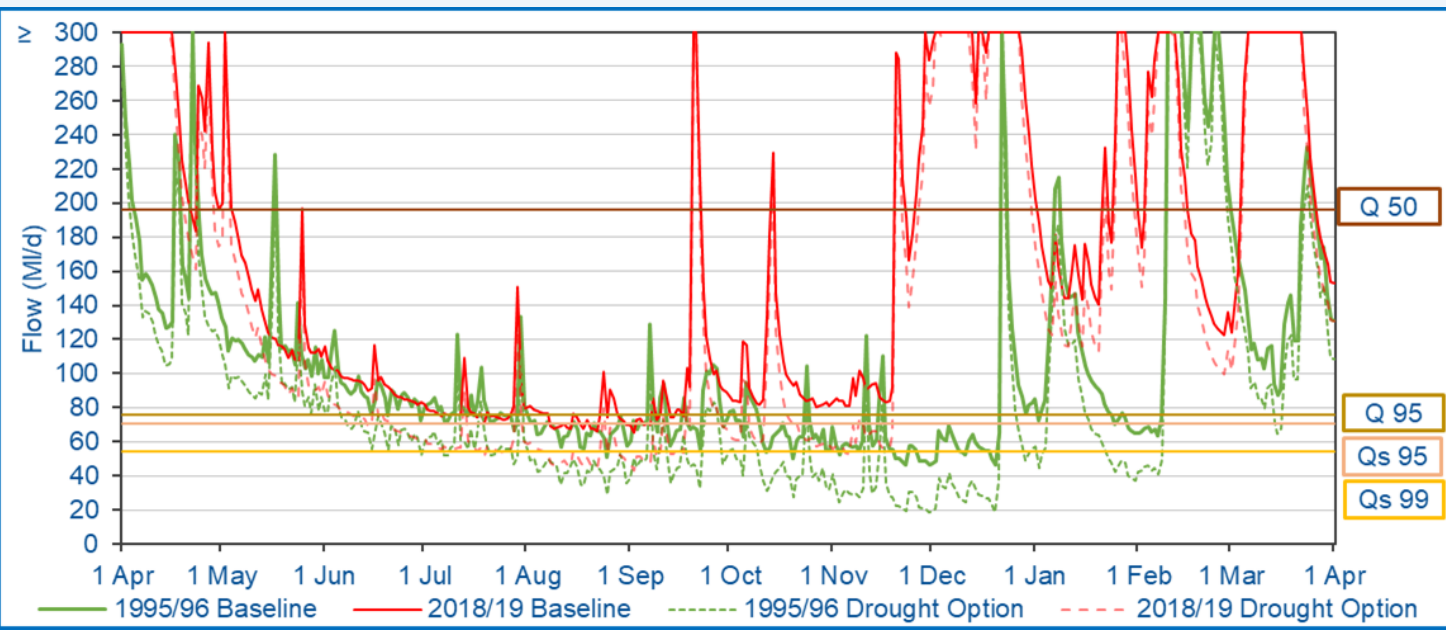
River Flow Regime

Reference Conditions (MI/d)	Drought Plan Conditions (MI/d)	% Reduction	Impact
Qs95	70.85	49.93	30	Summer Major
Qs99	54.47	33.55	38	
Q95	75.77	50.64	33	Winter Major
Q50	196.28	171.15	13

Significant Flow Additions/Reductions	Flow Rate (MI/d)	Abstraction / Discharge
RIVER COLNE AND TRIBUTARIES - DALTON WORKS 2/27/11/059	67.2	Abstraction
RIVER COLNE AT ASPLEY, HUDDERSFIELD NE/027/0011/023	10-15	Abstraction
Supply To A Canal For Throughflow NE/027/0011/023	No value	Abstraction

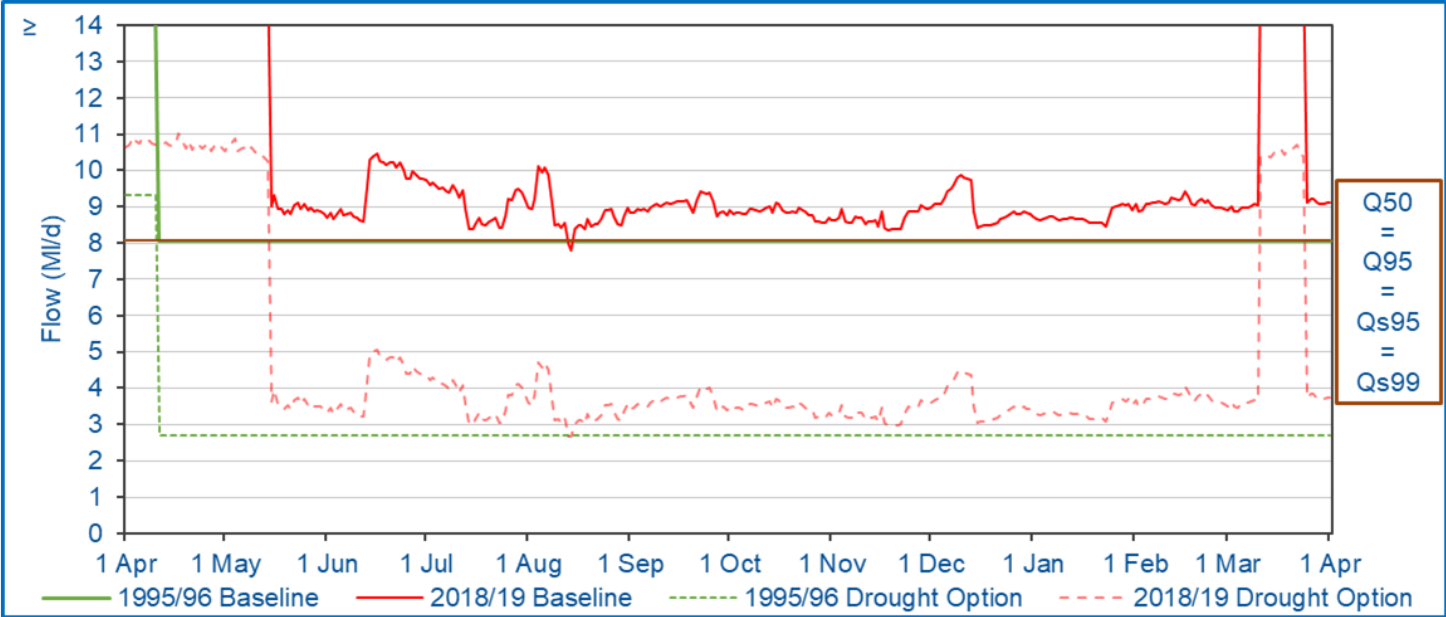
River Flow Regime

Reference Conditions (MI/d)	Drought Plan Conditions (MI/d)	% Reduction	Impact
Qs95	8.07	2.66	67	Summer Major
Qs99	8.07	2.66	67	
Q95	8.07	2.66	67	Winter Major
Q50	8.07	2.66	67

Significant Flow Additions/Reductions	Flow Rate (MI/d)	Abstraction / Discharge
WESSENDEN BROOK - MARSDEN 2/27/11/101	0.54552	Abstraction
WESSENDEN BROOK 2/27/11/102	6.78732	Abstraction

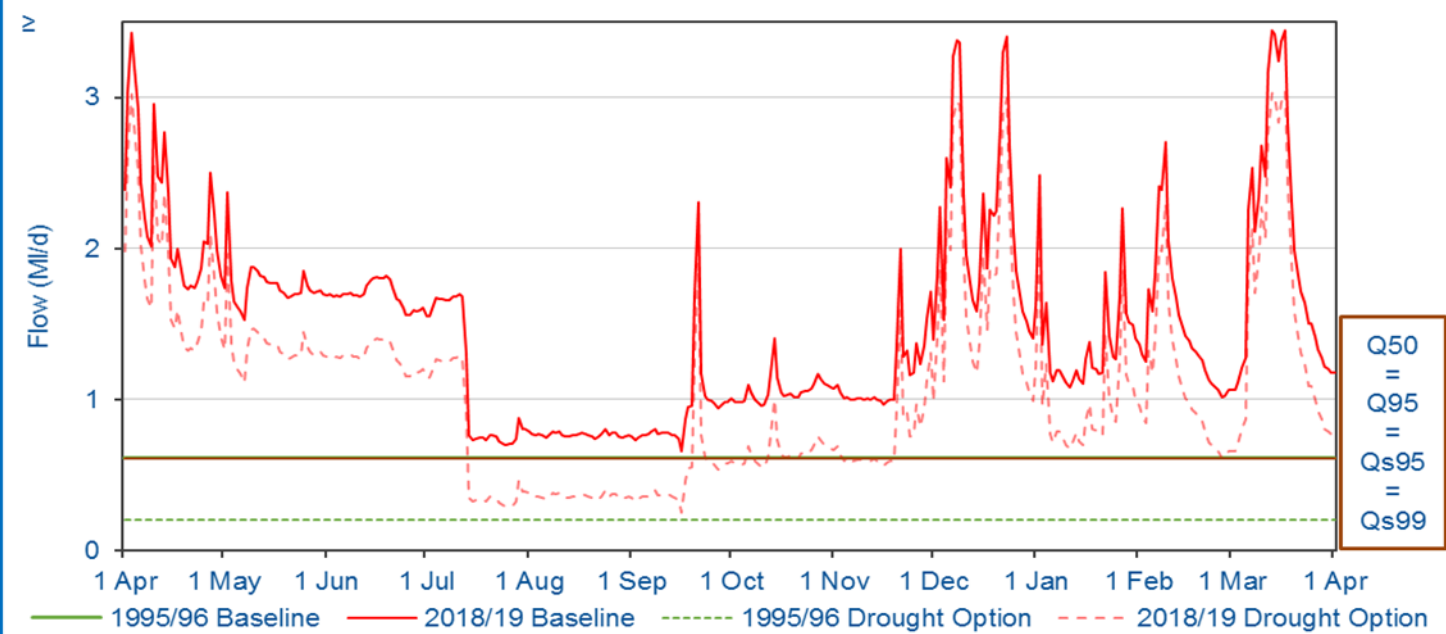
River Flow Regime

Reference Conditions (Ml/d)	Drought Plan Conditions (Ml/d)	% Reduction	Impact
Q <sub>s</sub> 95	0.61	0.20	67	Summer Major
Q <sub>s</sub> 99	0.61	0.20	67	
Q95	0.61	0.20	67	Winter Major
Q50	0.61	0.20	67

**There are no significant flow additions/reductions associated with this reach**

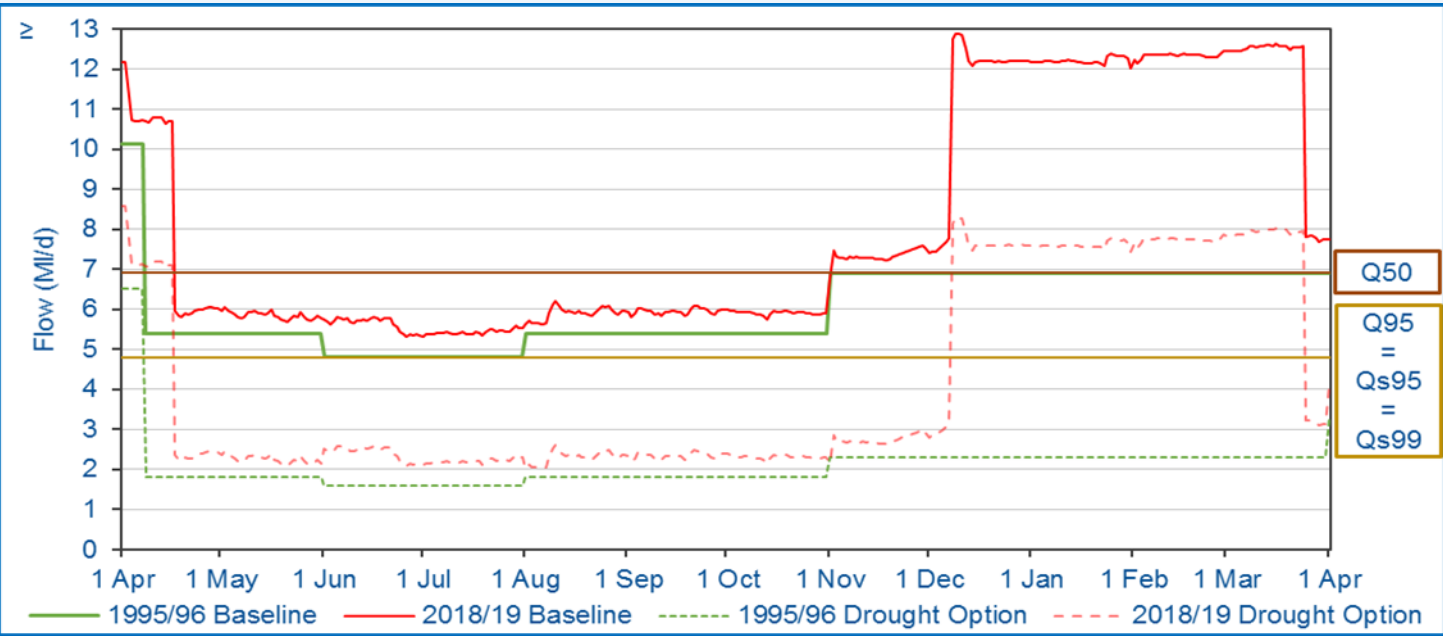
River Flow Regime

Reference Conditions (M/d)	Drought Plan Conditions (M/d)	% Reduction	Impact
Qs95	4.80	1.58	67	Summer Major
Qs99	4.80	1.58	67	
Q95	6.90	2.28	67	Winter Major
Q50	6.90	2.28	67

There are no significant flow additions/ reductions associated with this reach

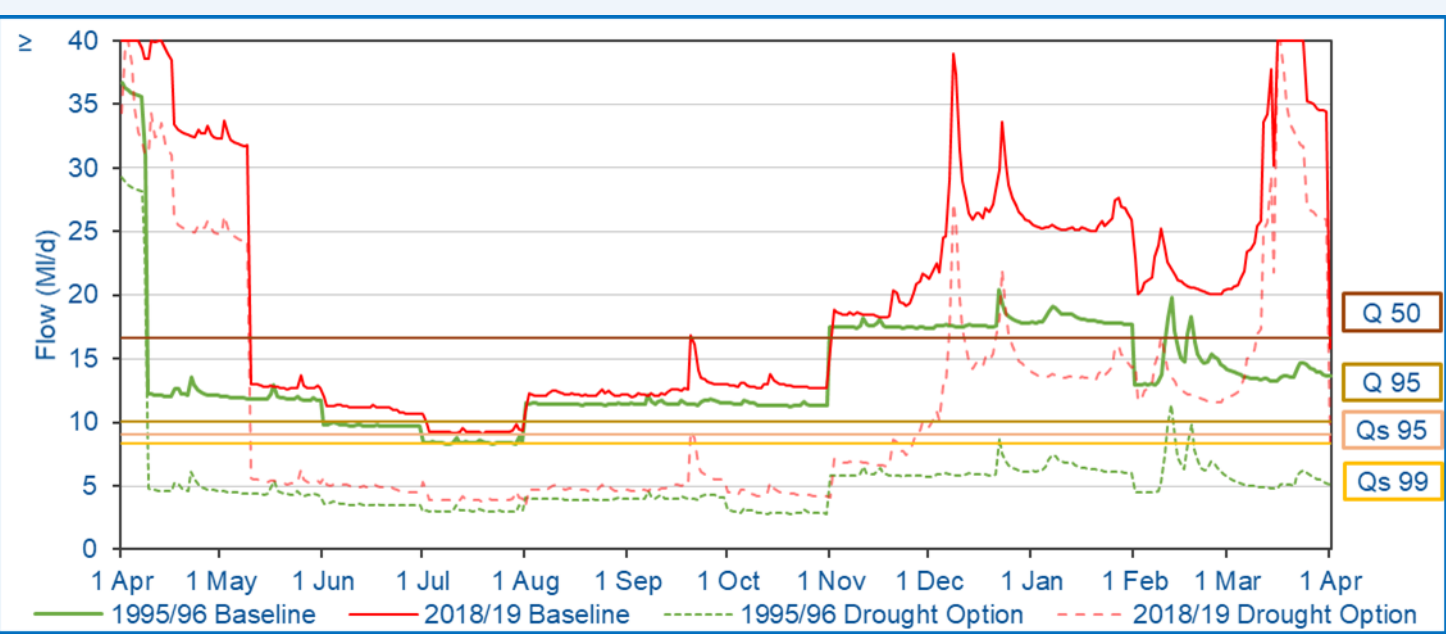
River Flow Regime

Reference Conditions (ML/d)	Drought Plan Conditions (ML/d)	% Reduction	Impact
Qs95	9.21	Min 2.64-3.69	Up to 67	Summer Major
Qs99	8.36	Min 2.64-3.69	Up to 67	Major
Q95	10.05	Min 3.69-5.78	Up to 67	Winter Major
Q50	17.26	Min 3.69-5.78	Up to 67	Major

**There are no significant flow additions/ reductions associated with this reach**

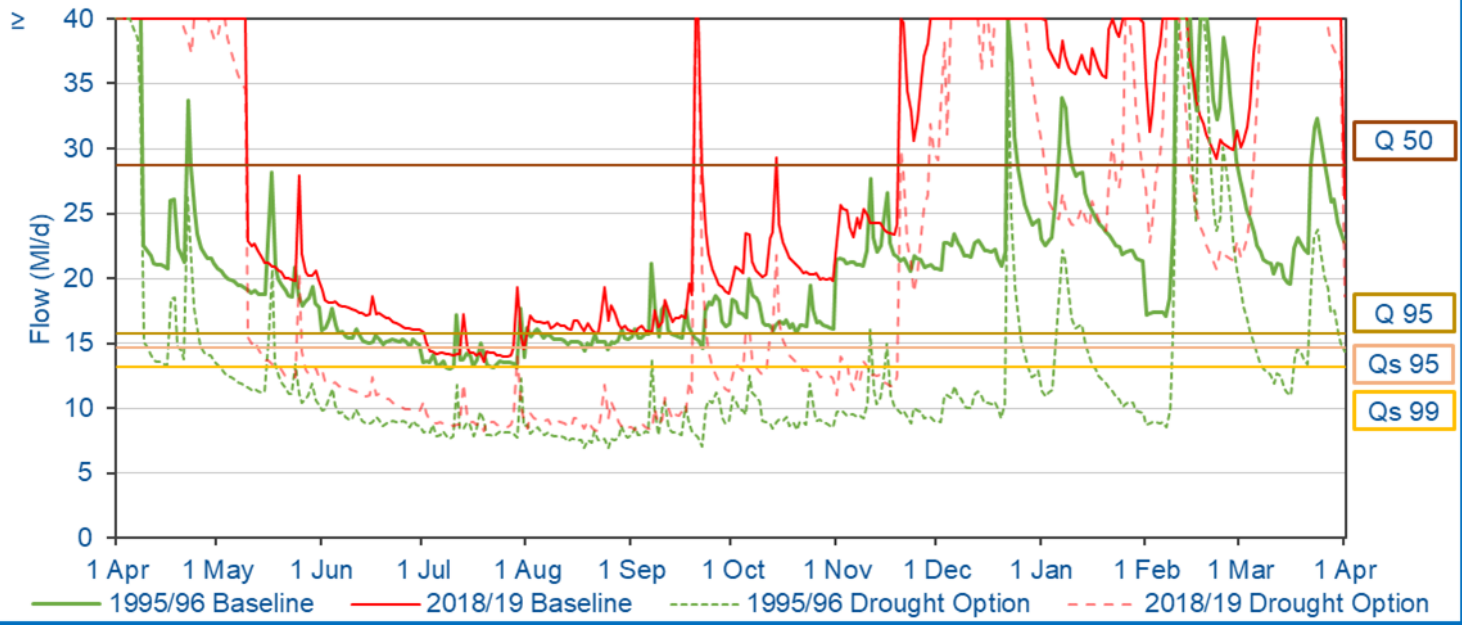
River Flow Regime

Reference Conditions (Ml/d)	Drought Plan Conditions (Ml/d)	% Reduction	Impact
Qs95	14.69	7.18	51	Summer Major
Qs99	13.18	6.30	57	
Q95	15.73	Min of 5.67	64	Winter Major
Q50	28.73	17.01	41

Significant Flow Additions/Reductions	Flow Rate (Ml/d)	Abstraction / Discharge
NEILEY WWTW 2255	7.497	Discharge

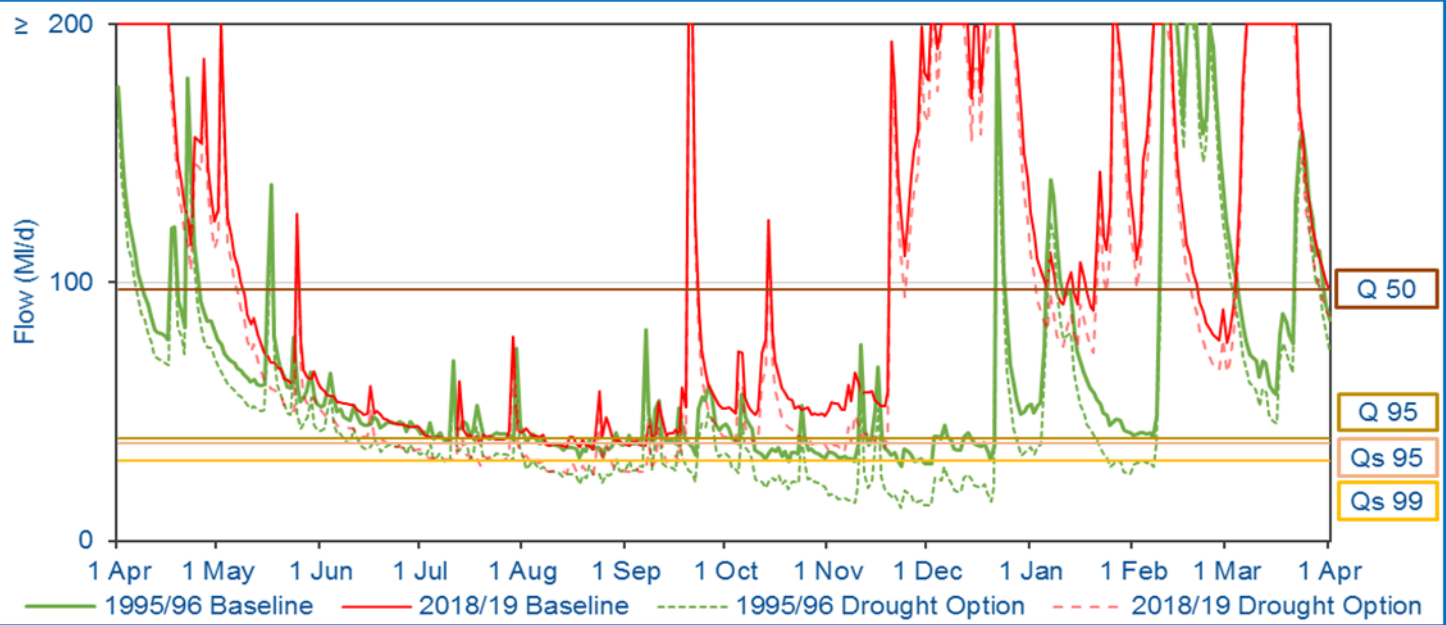
River Flow Regime

Reference Conditions (Ml/d)	Drought Plan Conditions (Ml/d)	% Reduction	Impact
Q <sub>s</sub> 95	37.71	28.42	25	Summer Major
Q <sub>s</sub> 99	31.49	22.20	30	
Q95	39.96	26.46	34	Winter Major
Q50	98.47	84.97	14

Significant Flow Additions/Reductions	Flow Rate (Ml/d)	Abstraction / Discharge
RIVER HOLME - HUDDERSFIELD 2/27/10/088	181.84	Abstraction

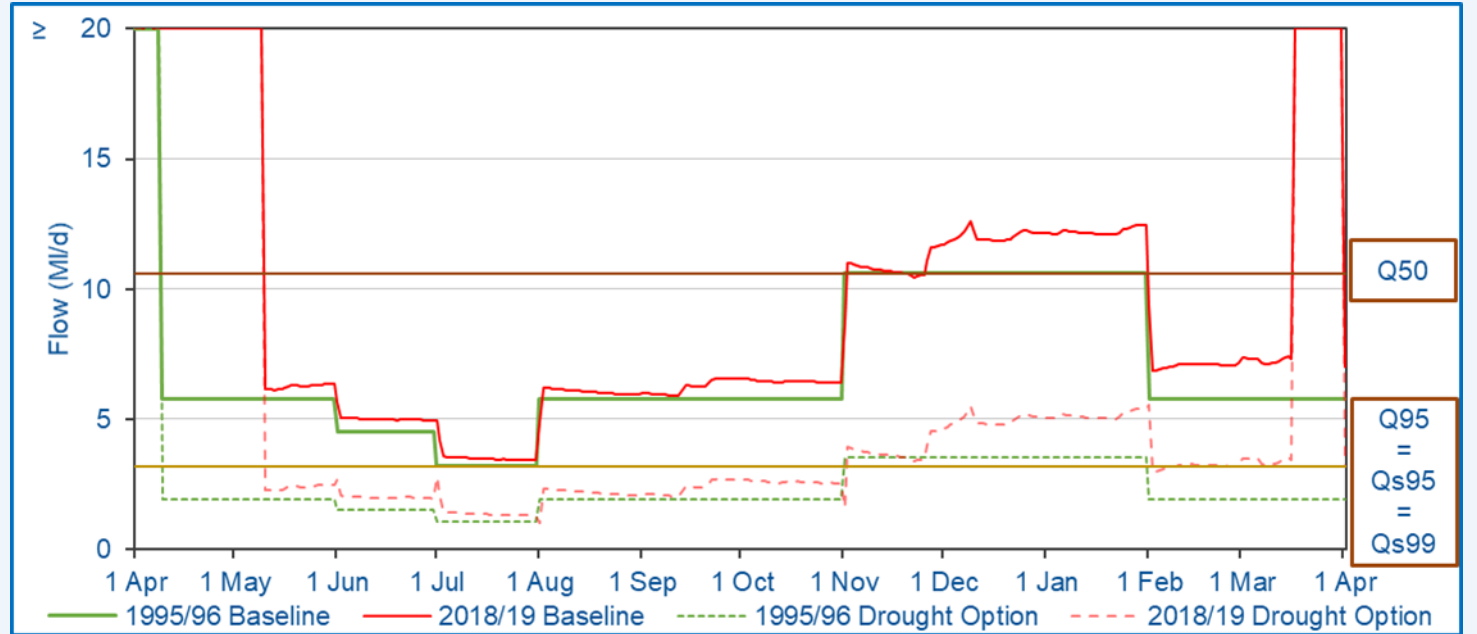
River Flow Regime

Reference Conditions (MI/d)	Drought Plan Conditions (MI/d)	% Reduction	Impact
Q <sub>s</sub> 95	3.20	1.06	67	Summer Major
Q <sub>s</sub> 99	3.20	1.06	67	
Q95	10.60	3.50	67	Winter Major
Q50	10.60	3.50	67

There are no significant flow additions/reductions associated with this reach

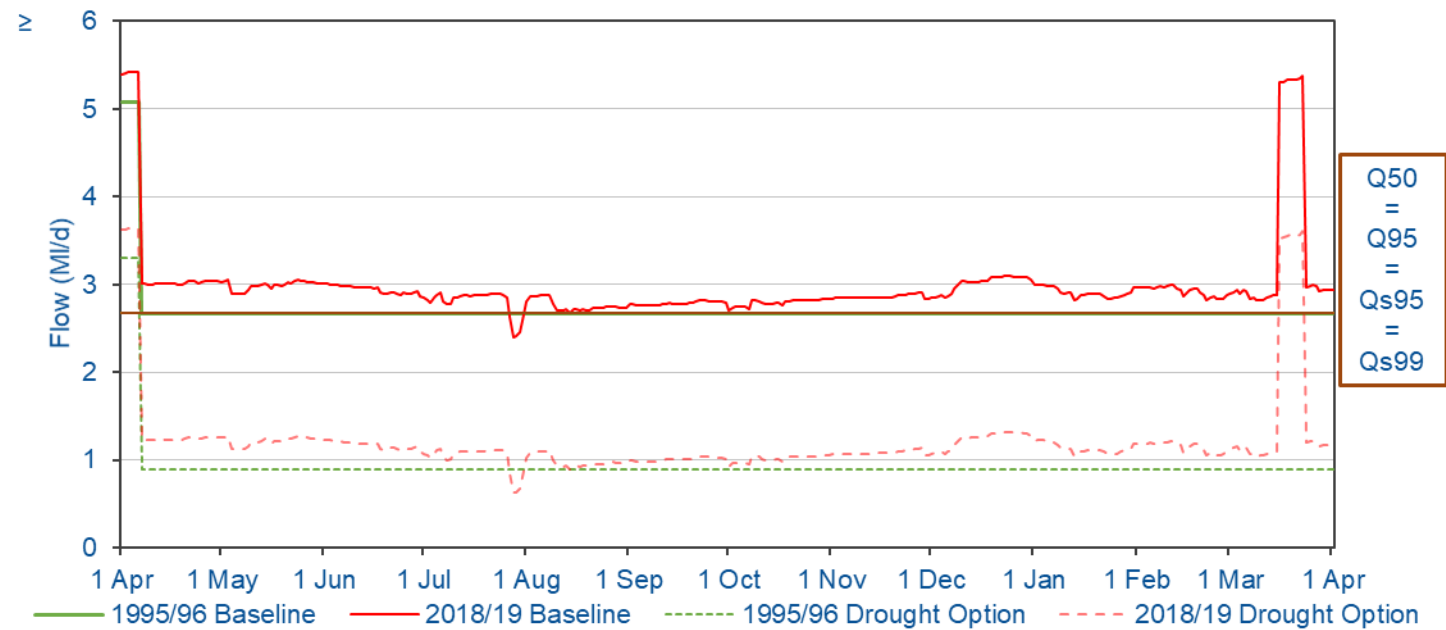
River Flow Regime

Reference Conditions (MI/d)	Drought Plan Conditions (MI/d)	% Reduction	Impact	Significant Flow Additions/Reductions	Flow Rate (MI/d)	Abstraction / Discharge
-					MAG BROOK-HONLEY-HUDDERSFIELD 2/27/10/030	0.35	Abstraction
Q <sub>s95</sub>	2.67	0.88	67	Summer Major	MELTHAM STW WRA6680	2.35	Discharge
Q <sub>s99</sub>	2.67	0.88	67		BROW GRAINS DIKE AT NEW BRIDGE ROAD, MELTHAM; 2/27/10/125/R01	2.33	Abstraction
Q95	2.67	0.88	67	Winter Major	MELTHAM DYKE VIA MILL DAM NE/027/0010/001	0.325	Abstraction
Q50	2.67	0.88	67

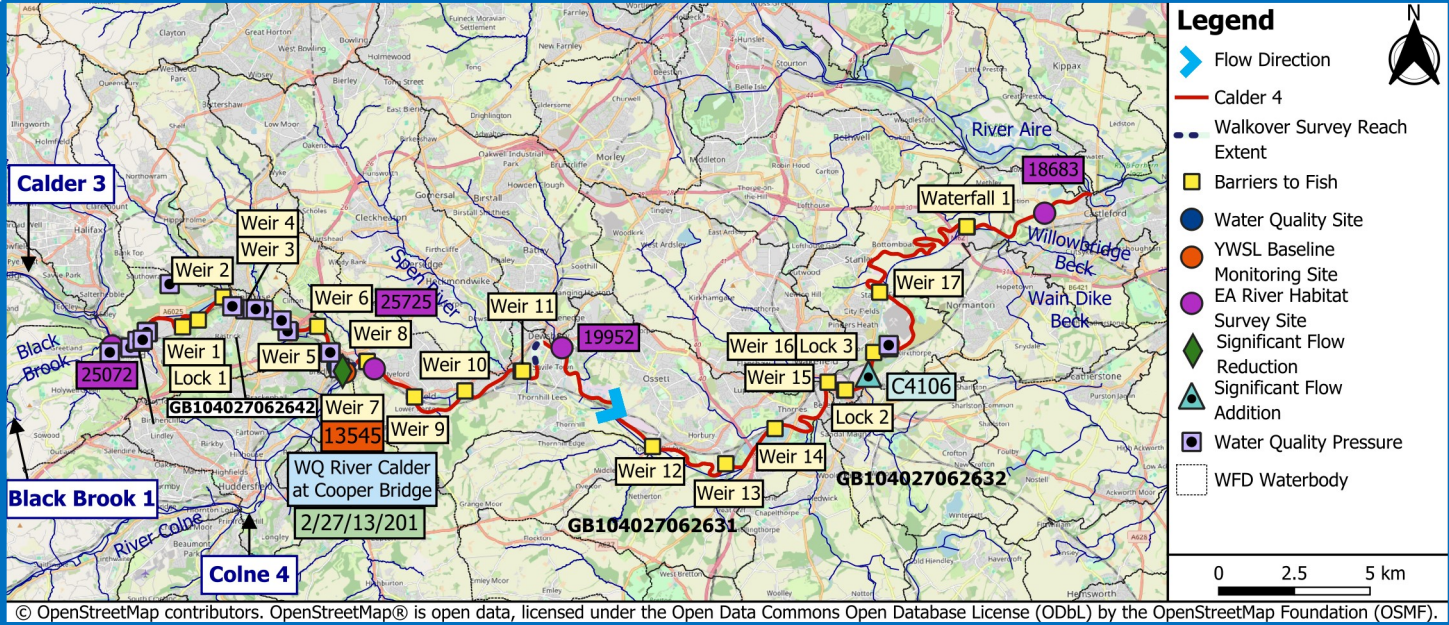
Reach Setting

The bedrock geology is dominated by the Penine Coal Measures Group and superficial geology is dominated by alluvium beneath the channel with scattered river terrace deposits along the reach, particularly in the lower sections of the reach. Soils are mainly composed of loamy and clayey floodplain soils with slowly permeable, seasonally wet acid loamy and clayey soils further out from the river. The river passes significant urban areas of West Yorkshire, namely Mirfield, Dewsbury, Wakefield and Castleford.

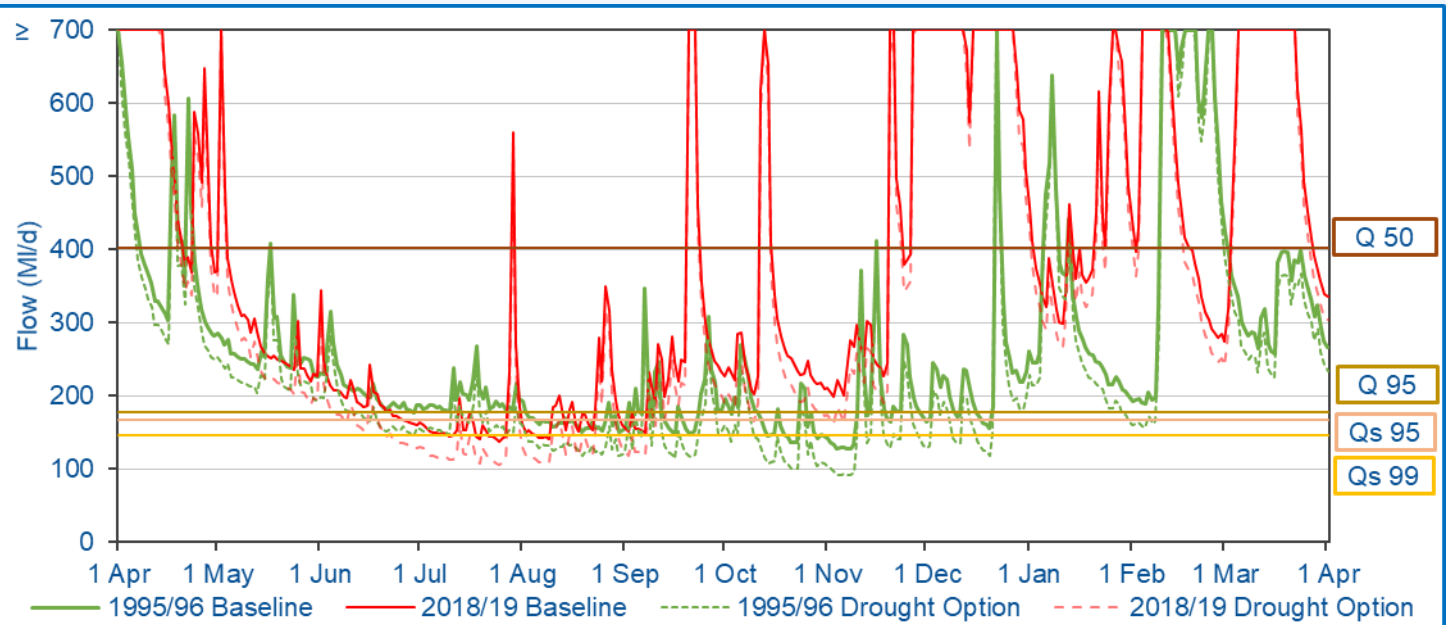
River Flow Regime

Reference Conditions (MI/d)	Drought Plan Conditions (MI/d)	% Reduction	Impact	Significant Flow Additions/Reductions	Flow Rate (MI/d)	Abstraction / Discharge
					CALDERVALE (WAKEFIELD) STW C4106	32 (DWF)	Discharge
	Q <sub>s95</sub>	168.75	137.26	18.7	RIVER CALDER - DALTON WORKS - HUDDERSFIELD 2/27/13/201	27.3	Abstraction
	Q <sub>s99</sub>	148.61	117.12	21.2			
	Q <sub>95</sub>	177.12	140.90	20.4			
Q <sub>50</sub>	401.76	365.54	7.8
