Reach Setting

Figure A4.1
Graining Water T1
Physical Environment Information

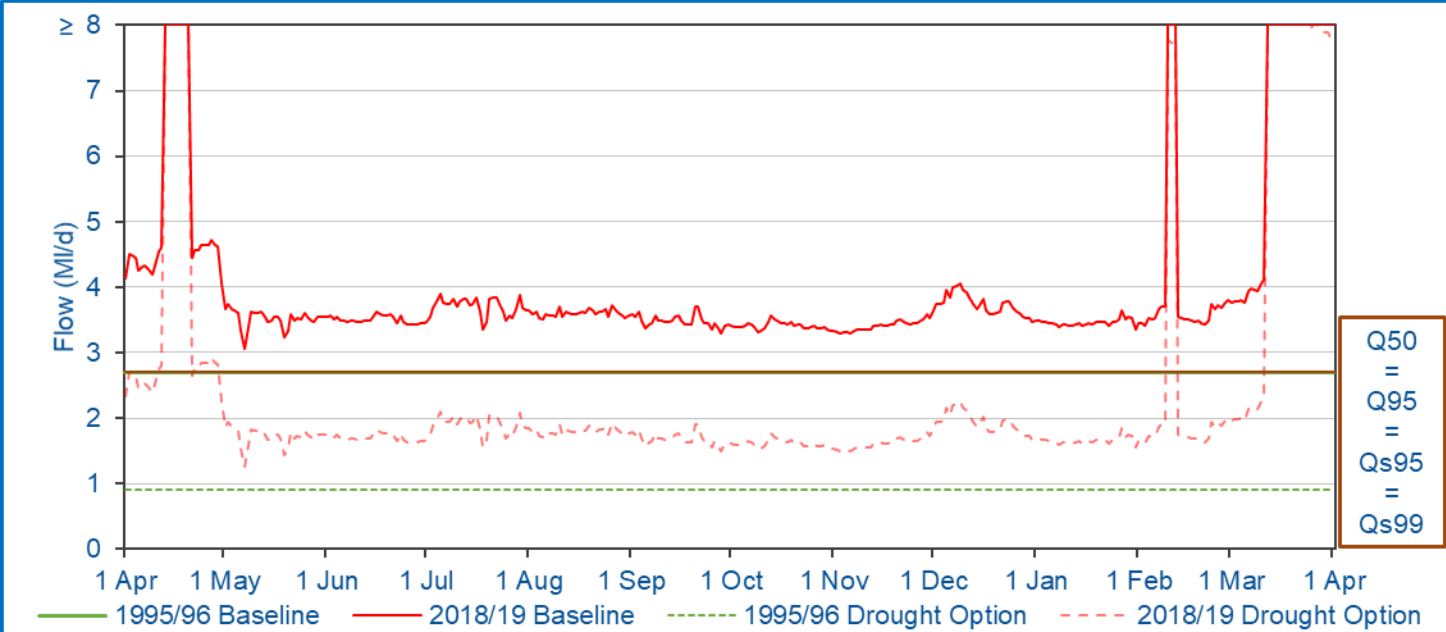
River Flow Regime

Reference Conditions (MI/d)	Drought Plan Conditions (MI/d)	% Reduction	Impact
Q _s 95	2.70	0.89	67	Summer
Q _s 99	2.70	0.89	67	Major
Q95	2.70	0.89	67	Winter
Q50	2.70	0.89	67	Major

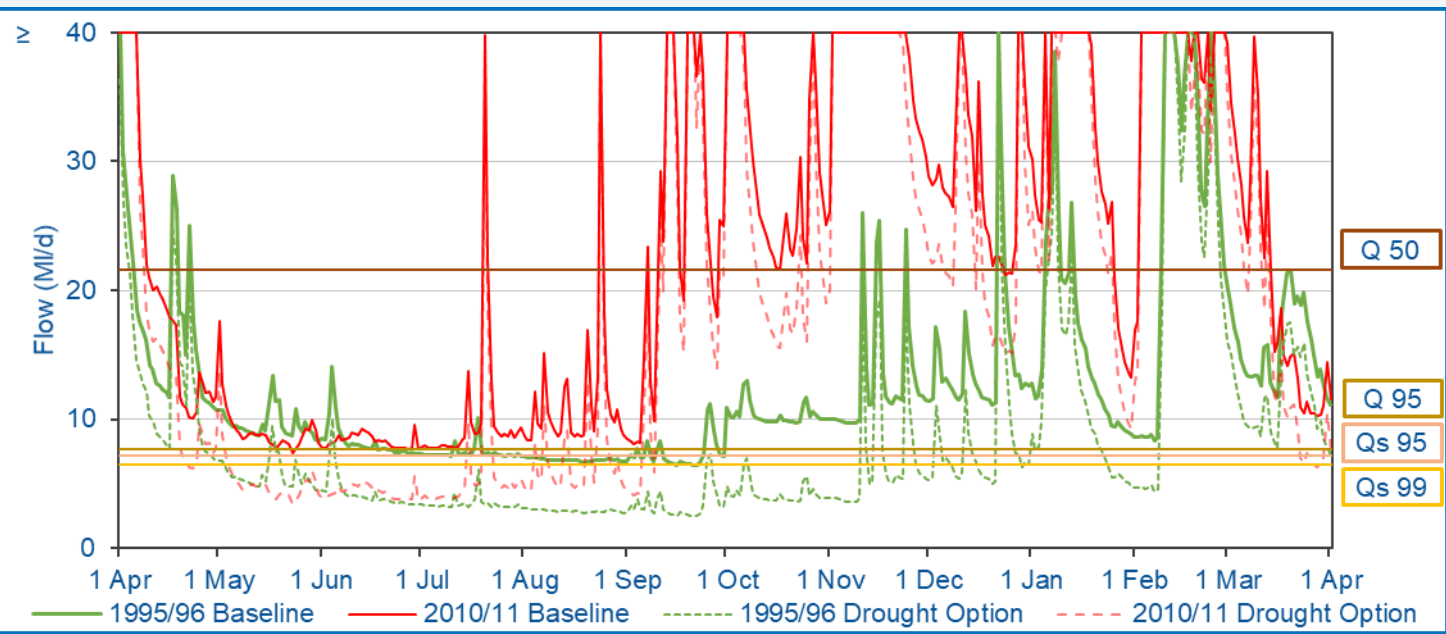
River Flow Regime

Reference Conditions (Ml/d)	Drought Plan Conditions (Ml/d)	% Reduction	Impact
Q _s 95	7.21	3.23	55	Summer Major
Q _s 99	6.54	2.56	61	
Q95	7.67	3.04	60	Winter Major
Q50	21.7	15.5	29

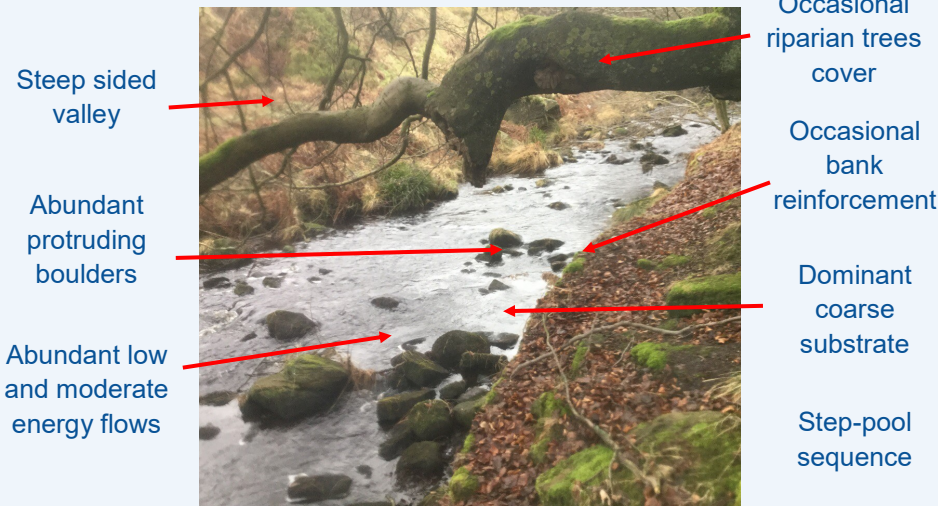
Dominant upland riparian vegetation

Occasional boulders on bankside

Dominant coarse substrate

Abundant exposed boulders

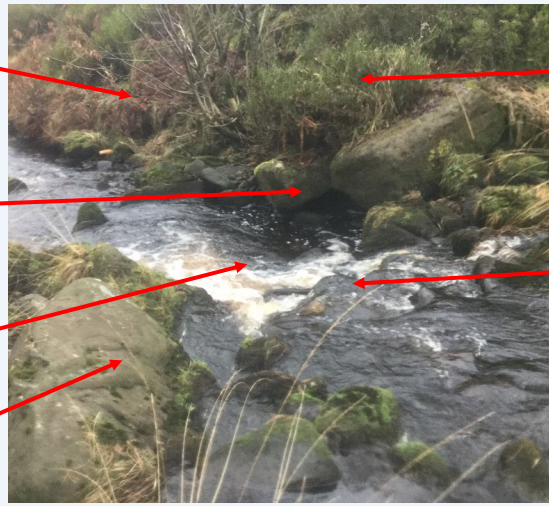
Abundant steep sided banks

Abundant moderate energy flows

Step-pool sequence

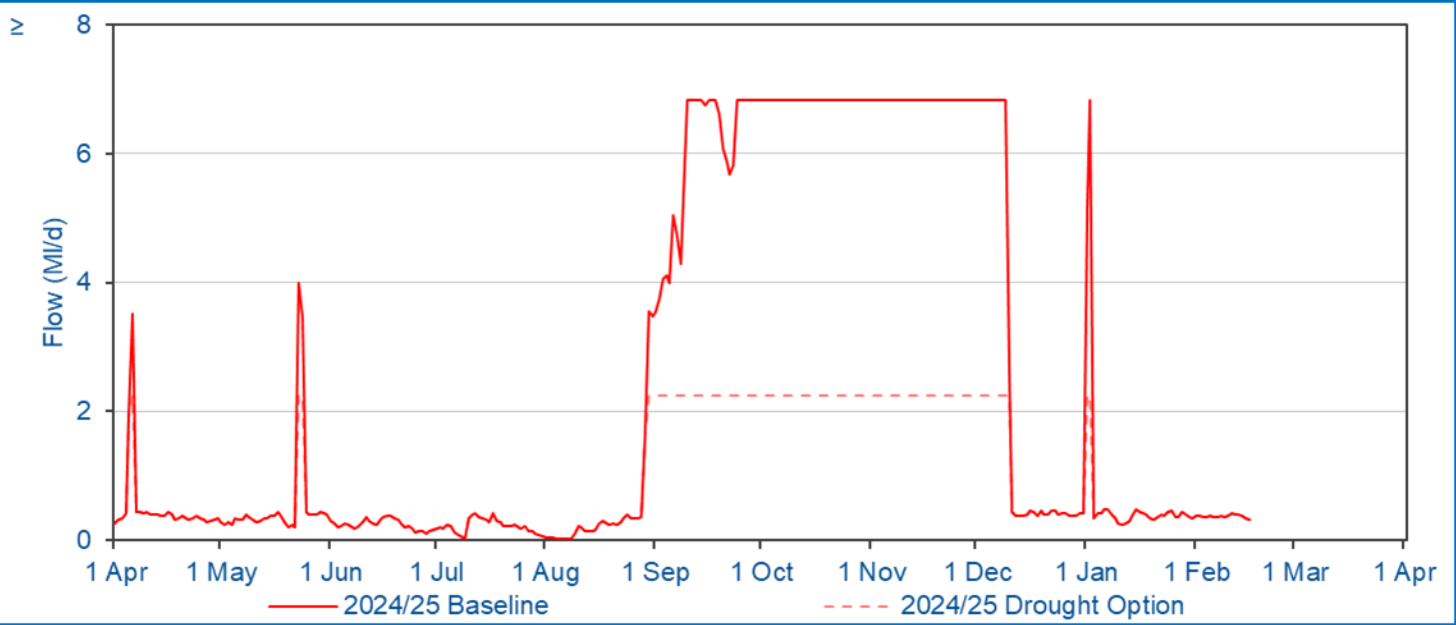
River Flow Regime

Reduction in flows by up to 67% at times when abstraction is occurring. Potential for a **major** hydrological impact at any time of year noting that the lowest natural flows are protected by the prescribed flow condition.
