Figure A4.14

Harden Beck 1

Physical Environment Information

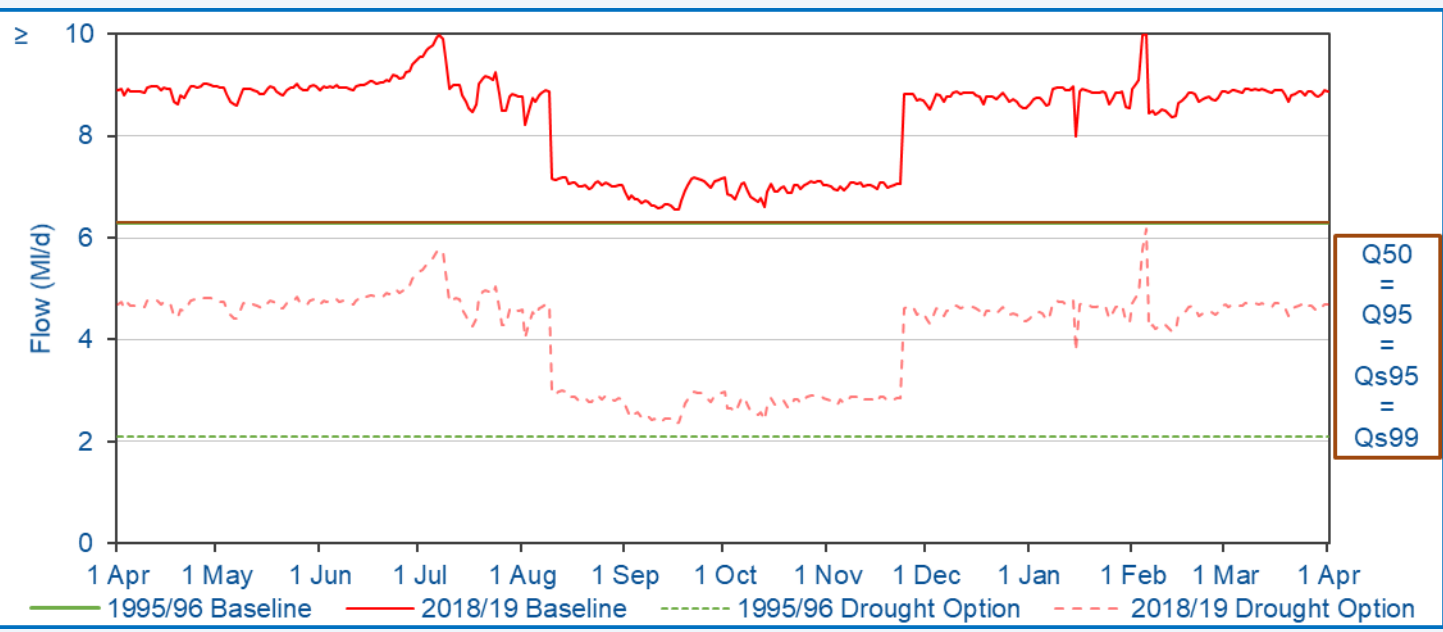
Reference Conditions (Ml/d)	Drought Plan Conditions (Ml/d)	% Reduction	Impact
Q _s 95	6.30	2.08	67	Summer Major
Q _s 99	6.30	2.08	67	
Q95	6.30	2.08	67	Winter Major
Q50	6.30	2.08	67

There are no significant flow additions/reductions associated with this reach

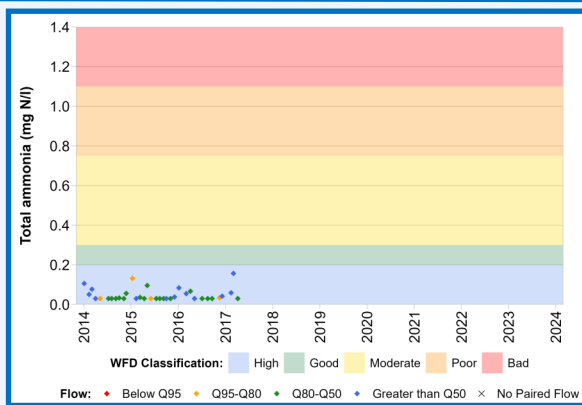
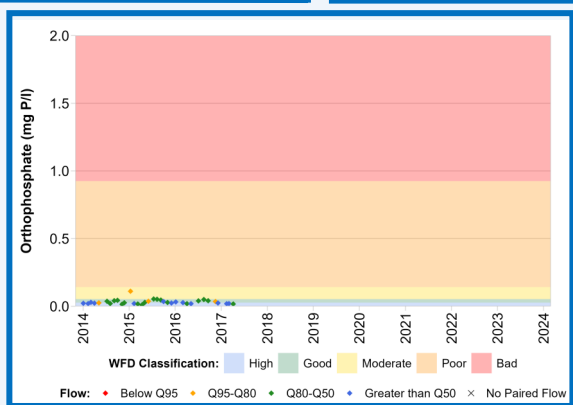
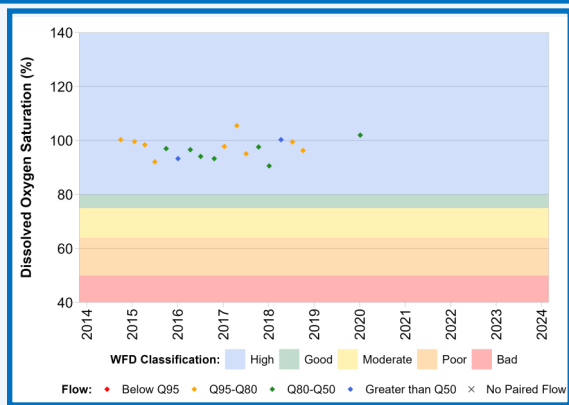
Figure A4.15

Loadpit Beck 1

Physical Environment Information

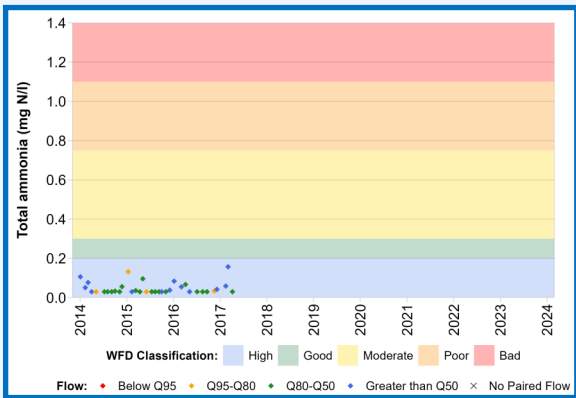
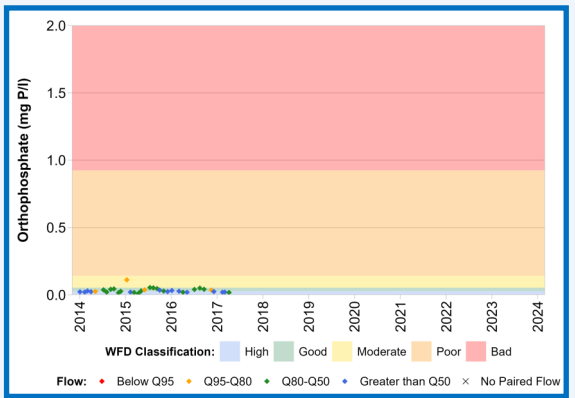
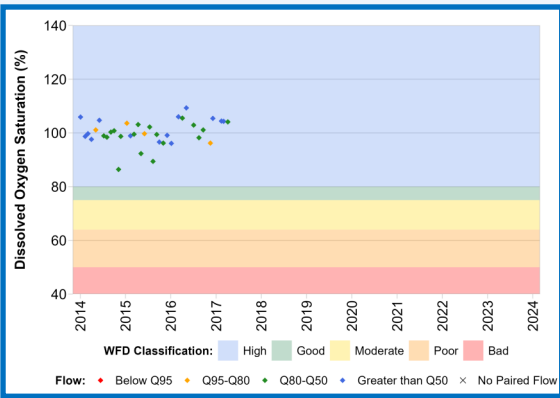
Figure A4.16

Gill Beck 1

Physical Environment Information

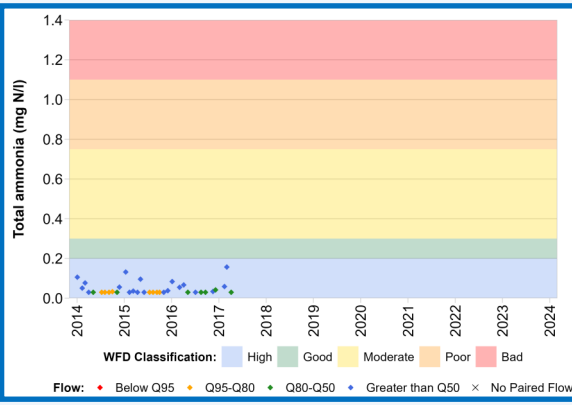
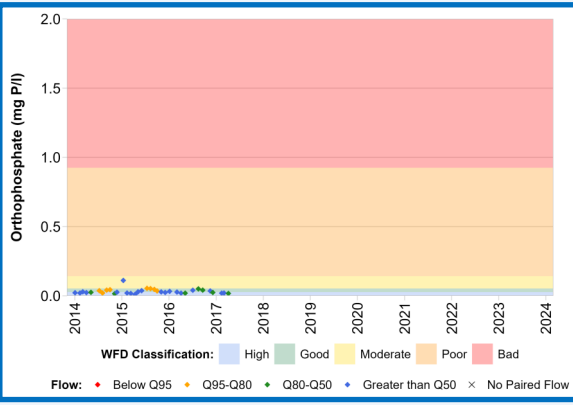
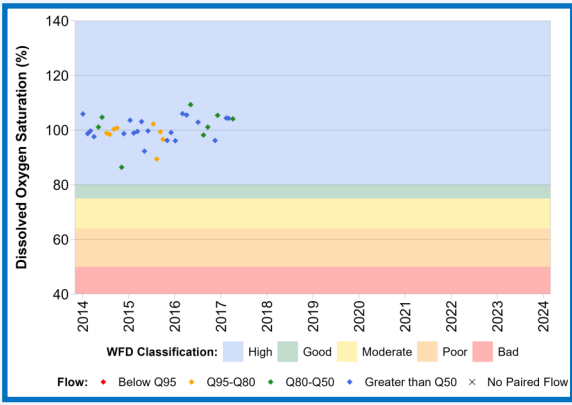
Figure A4.17
Gill Beck 2
Physical Environment Information

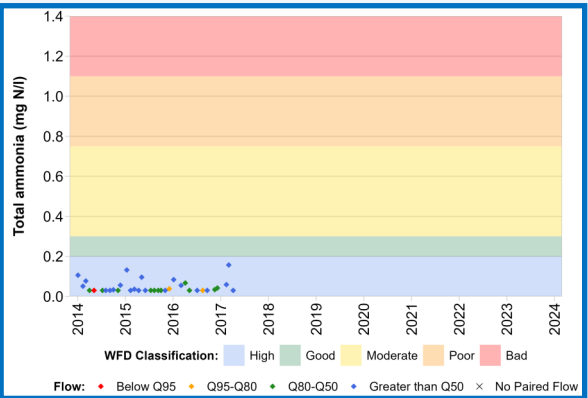
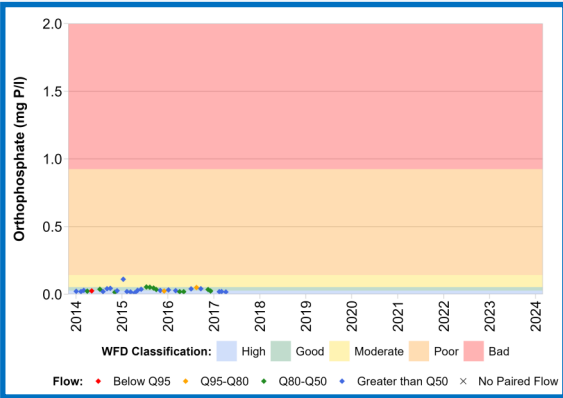
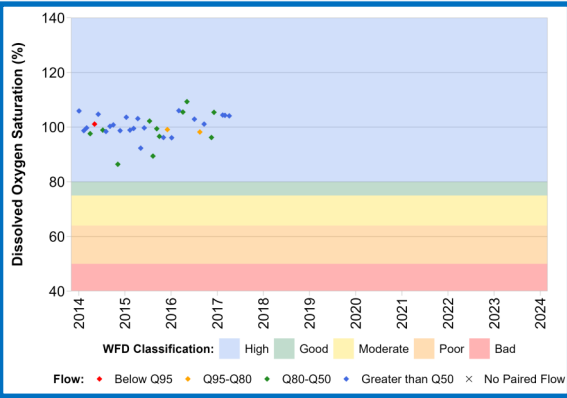
Figure A4.18
Jum Beck 1

Physical Environment Information

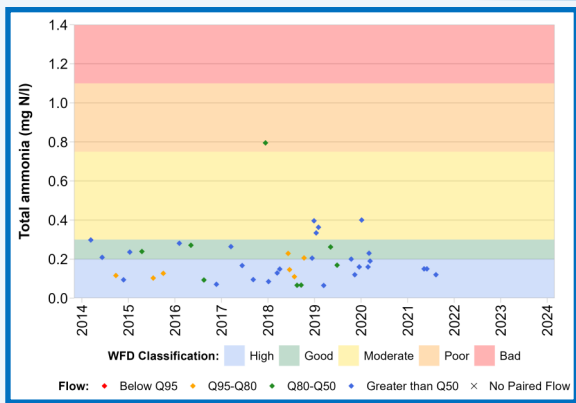
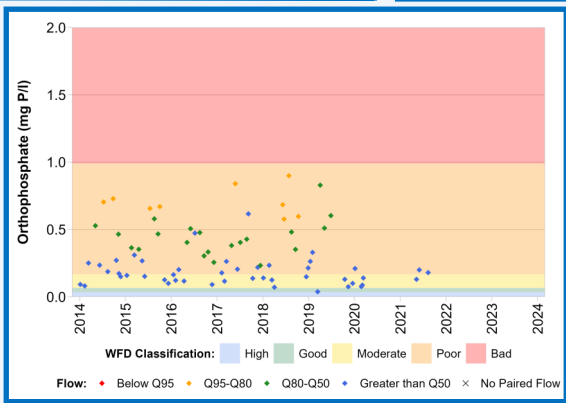
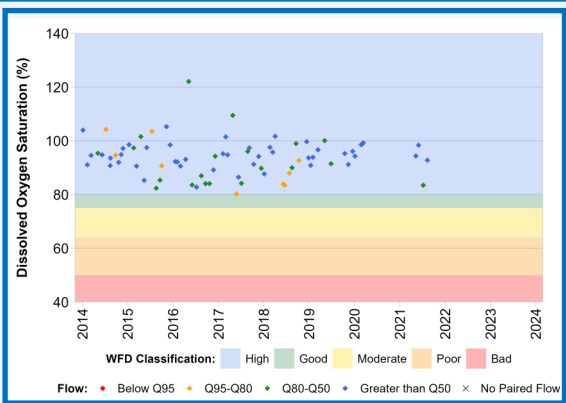
Figure A4.19

River Aire 1

Physical Environment Information

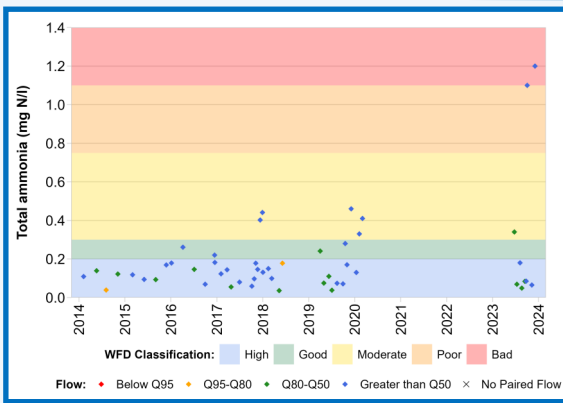
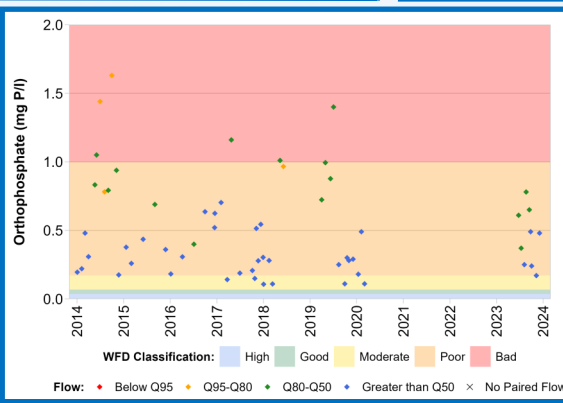
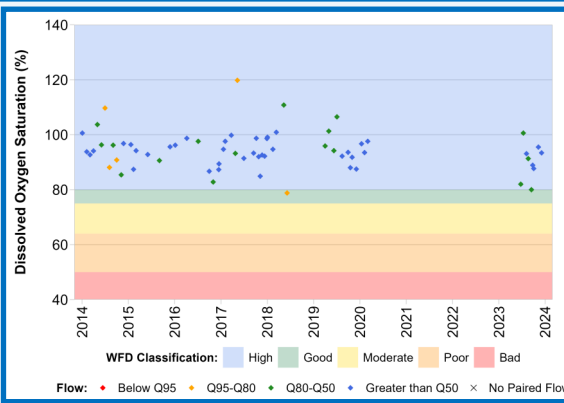
Figure A4.20
River Aire 2

Physical Environment Information

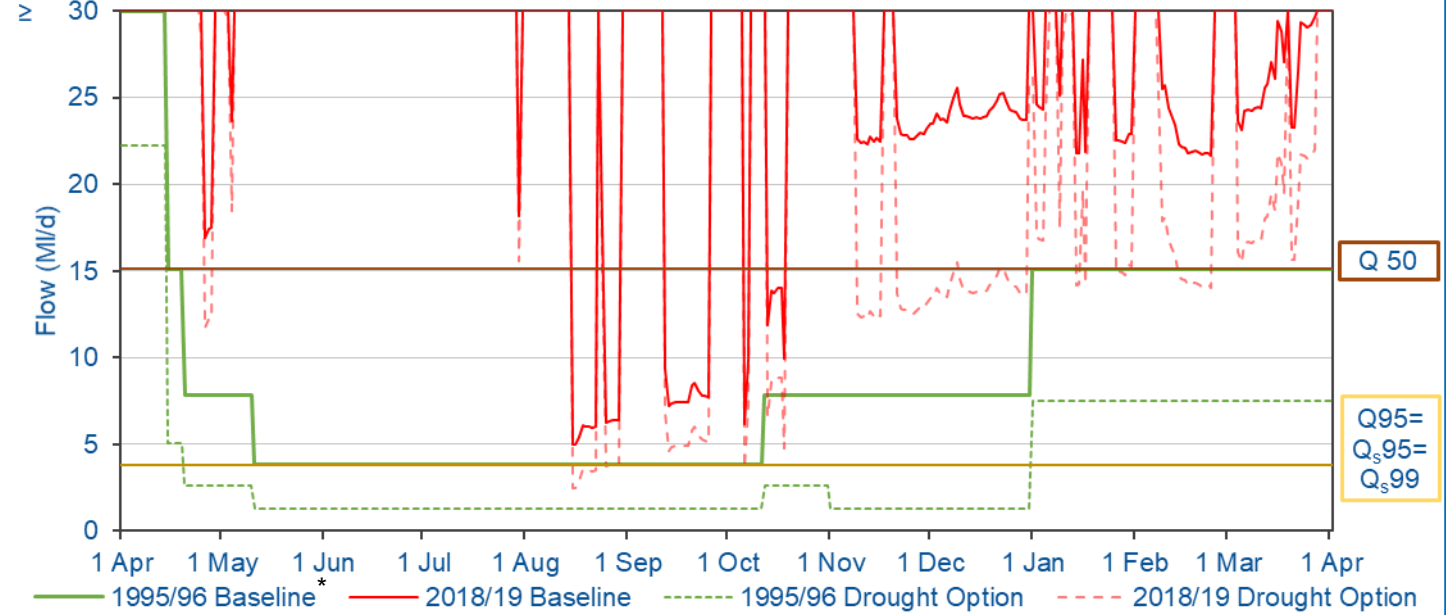
Reference Conditions (ML/d)	Drought Plan Conditions (ML/d)	% Reduction	Impact
Qs95	3.80	1.25	67	Summer Major
Qs99	3.80	1.25	67	
Q95	3.80	1.25	67	Winter Major
Q50	15.1	4.98	67

* the regulation regime in 1995/96 is not available and that the line is only a representation of the compensation flow (if it had been in place at that time).

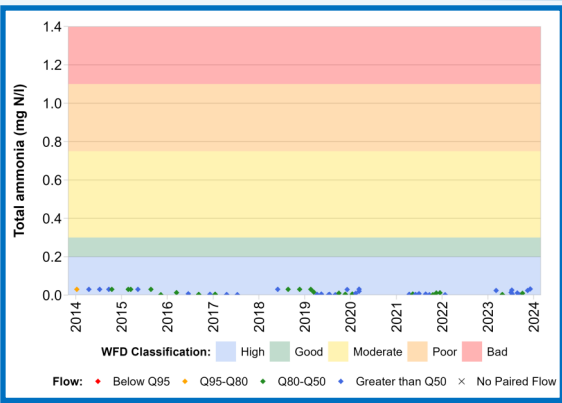
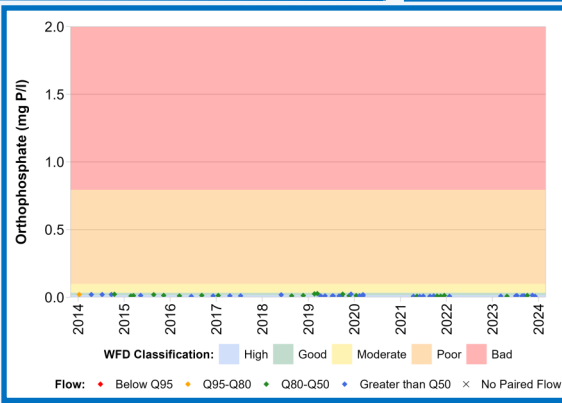
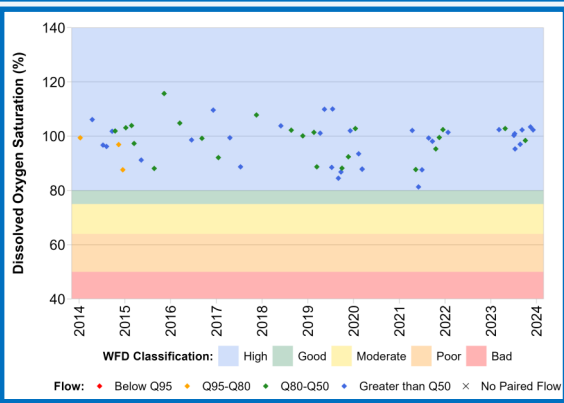
Figure A4.22
River Dibb 1

Physical Environment Information
