Figure A4.1
Eller Beck T1:
Physical Environment Information

Figure A4.2
Eller Beck 1
Physical Environment Information

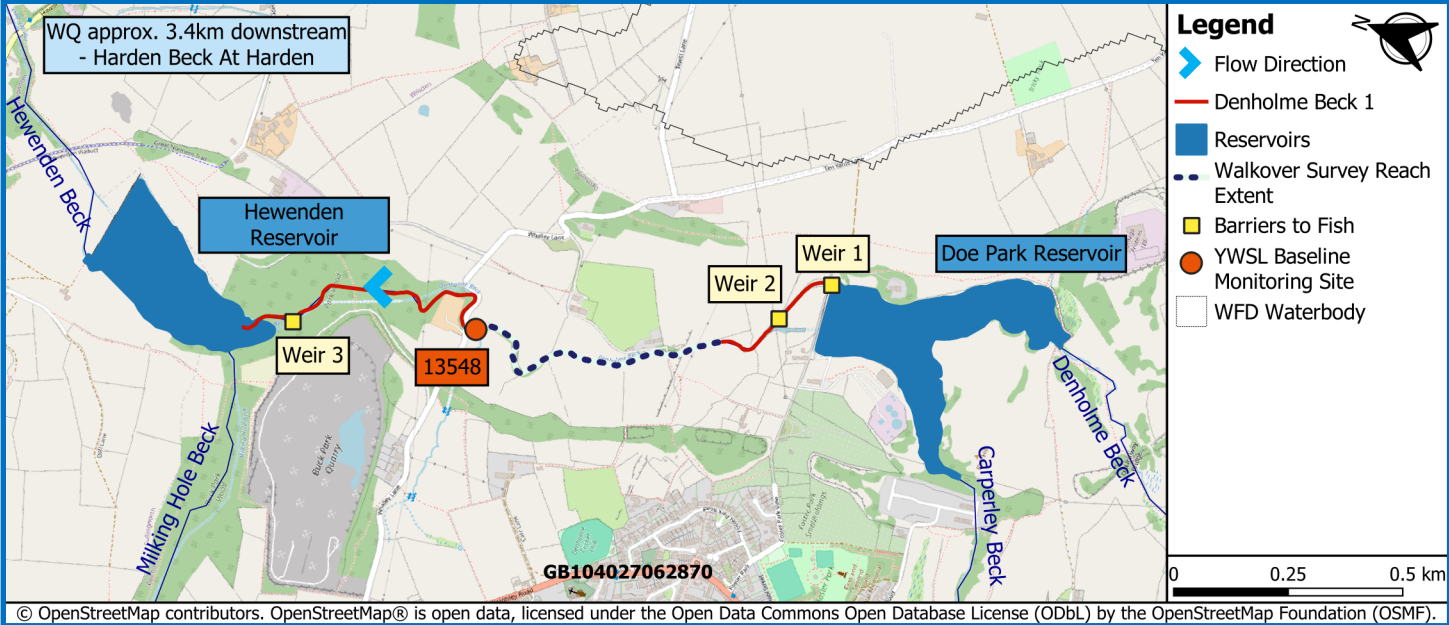
Reach Setting

The superficial geology is limited with only glacial till and some hummocky glacial deposits identified around the reservoir. Soils in the reservoir catchment are predominantly composed of a mixture of freely draining, slightly acid loamy soils around the reservoir and slowly permeable, wet, very acid upland soils in the remainder of the catchment. Urbanisation is very limited with a small group of houses located at ~0.3km and a farm located at ~0.8km downstream.

Supplementary Information
Catchment Area at Assessment Point	8.0km ²
Mean Slope Gradient	0.7°
Length of Reach	1.6km
Additional Catchment Area	1.3km ²
Upstream Reach	N/A
Downstream Reach	N/A
