Figure A4.1

Wharfe 1

Physical Environment Information

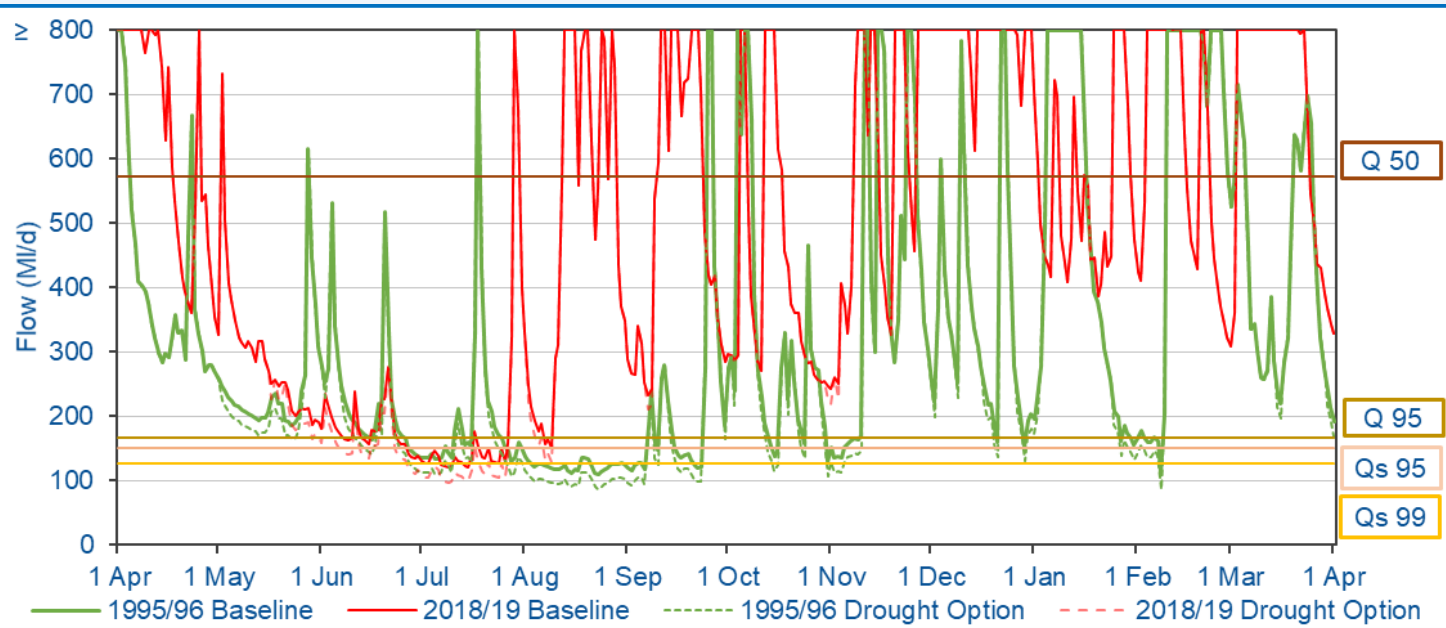
River Wharfe Flow Regime at Addingham Flow Gauge 27043

Reference Conditions (ML/d)	Drought Plan Conditions (ML/d)	% Reduction	Impact	Significant Flow Additions/Reductions	Flow Rate (ML/d)	Abstraction / Discharge
Q <sub>s</sub> 95	152.1	129.4	14.9	Summer Moderate	Wharfedale Hydro Power Ltd/ 2/27/19/206/R01	864.0	Abstraction
Q <sub>s</sub> 99	126.1	103.4	18.0				
Q95	167.6	144.9	13.5	Winter Minor	Whiteley Ltd/ 2/27/20/151	14.4	Abstraction
Q50	575.2	575.2	0.0
