Figure A4.1

Pott Beck 1:

Physical Environment Information

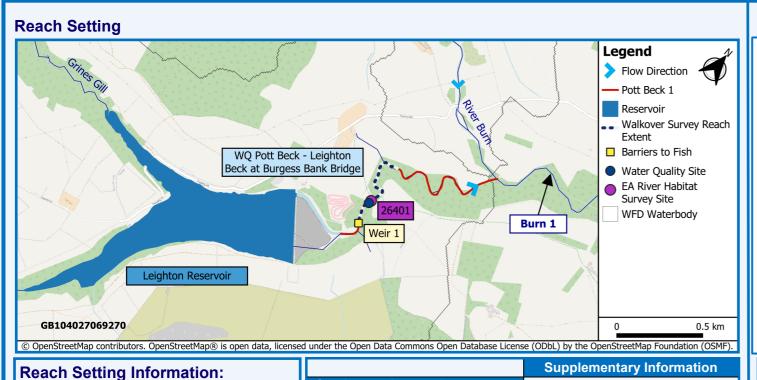
River Flow Regime	
≥ 20	
16	Q50 = Q95 =
© 12 home home home of the co	Qs95
	= Qs99
4 1 (1-1-1-1-1-1-1-1-1-1-1-1-1-1-1-1-1-1-	
0	
1 Apr 1 May 1 Jun 1 Jul 1 Aug 1 Sep 1 Oct 1 Nov 1 Dec 1 Jan 1 Feb 1 Mar 1 Apr 1995/96 Baseline —— 2018/19 Baseline1995/96 Drought Option 2018/19 Drought Op

-	Reference Conditions (MI/d)	Drought Option Conditions (MI/d)	% Reduction	Impact
Q _s 95	12.10	3.99	67	Summer
Q _s 99	12.10	3.99	67	Major
Q95	12.10	3.99	67	Winter
Q50	12.10	3.99	67	Major

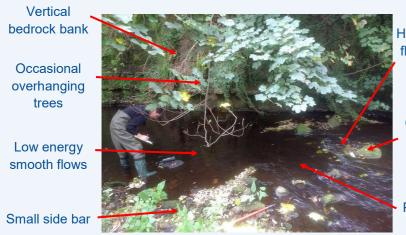
Higher energy flows around substrate

Occasional boulders

Peaty water

Abundant **Dominant** riparian riparian shading woodland **Abundant** Occasional gently sloped exposed tree earth banks roots Likely Riffle with dominant broken flow cobble substrate Dominant riffle-pool Note high flow

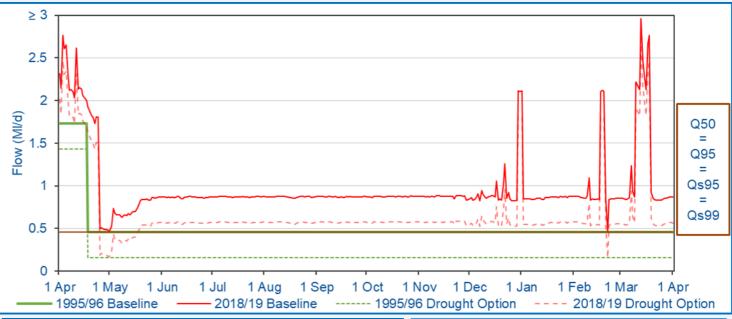
River Flow Regime

-	Reference Conditions (MI/d)	Drought Option Conditions (MI/d)	% Reduction	Impact
Q _s 95	0.46	0.15	67	Summer
Q _s 99	0.46	0.15	67	Major
Q95	0.46	0.15	67	Winter
Q50	0.46	0.15	67	Major

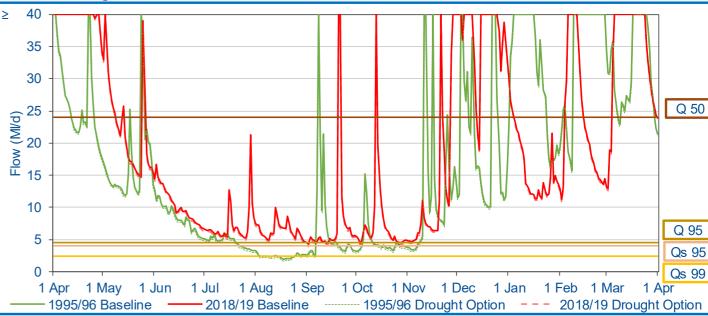
River Flow Regime

-	Reference Conditions (MI/d)	Drought Option Conditions (MI/d)	% Reduction	Impact
Q _s 95	4.05	3.74	7.7	Summer
Q _s 99	2.38	2.07	13	Minor
Q95	4.58	4.27	6.8	Winter
Q50	24.45	24.14	1.3	Negligible

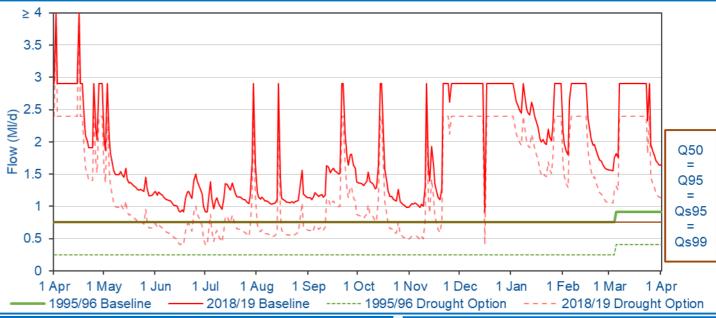
River Flow Regime

-	Reference Conditions (MI/d)	Drought Option Conditions (MI/d)	% Reduction	Impact
Q _s 95	0.75	0.25	67	Summer
Q _s 99	0.75	0.25	67	Major
Q95	0.75	0.25	67	Winter
Q50	0.75	0.25	67	Major

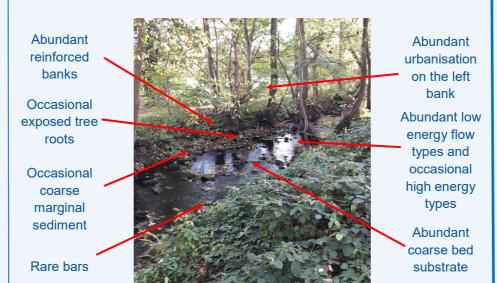
Frequent vertical earth banks

Bridge.
Abundant
anthropogenic
features and
barriers along
reach

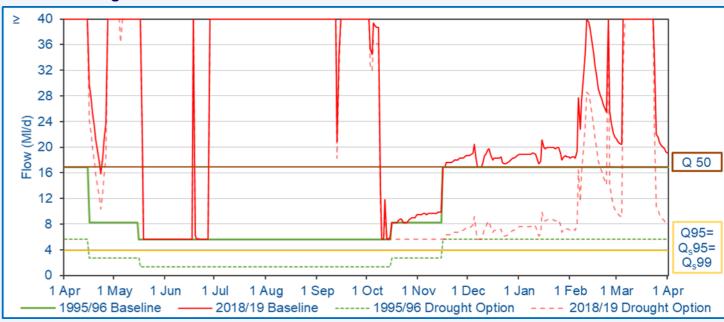
River Flow Regime

-	Reference Conditions (MI/d)	Drought Plan Conditions (MI/d)	% Reduction	Impact
Q _s 95	3.90	1.29	67	Summer
Q _s 99	3.90	1.29	67	Major
Q95	3.90	1.29	67	Winter
Q50	16.90	5.58	67	Major
